**RESURFACING AND PAVING
OF THE NEMASKA ACCESS
ROAD -
NEMASKA (QUÉBEC)**

Environmental Project Notice

Prepared for :
Cree Nation Government

157710050-202-105-EN-R0001-0A

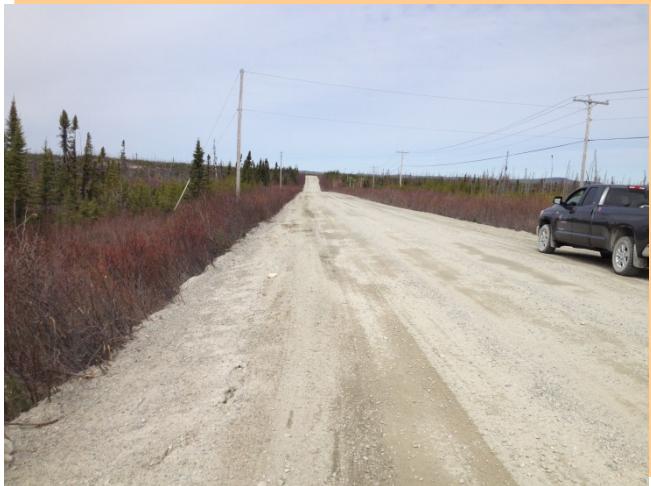
Photo 04: General – Soft shoulders

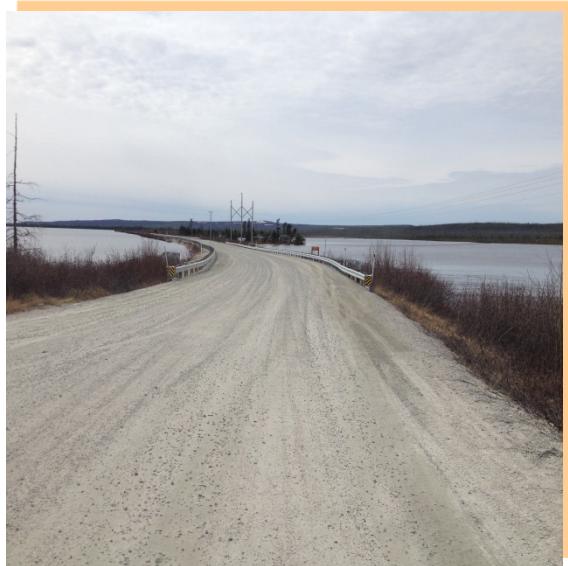
Photo 14: Guardrails 3+400

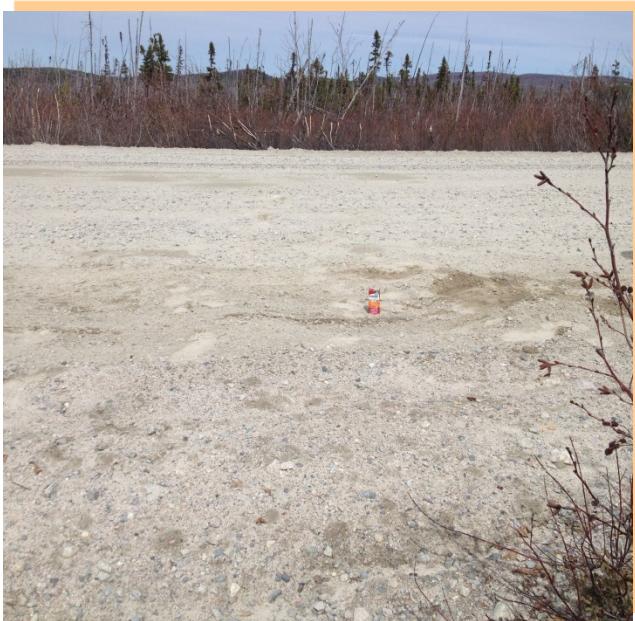
In some places the MG-20 granular material has completely disappeared, and vehicles travel on the coarse aggregate sub-base – see **photo 20**. On both sides the area of displaced MG-20 aggregate is about 2 m wide, but this surface cannot bear traffic. The actual width of the road is about 8 m. In order to ensure satisfactory frost behaviour of the planned road and the structural capacity required for the volume of local heavy traffic, the geotechnical study recommends the following road structure:

Photo 20: 4+500 Sub-base Course aggregate – Surface

- Asphalt: latter revised to 70 mm;
 - Single layer ESG-14: 70 mm.
- Granular sub-base: 200 mm, MG-20;
- Subgrade: 250 mm, MG-112.

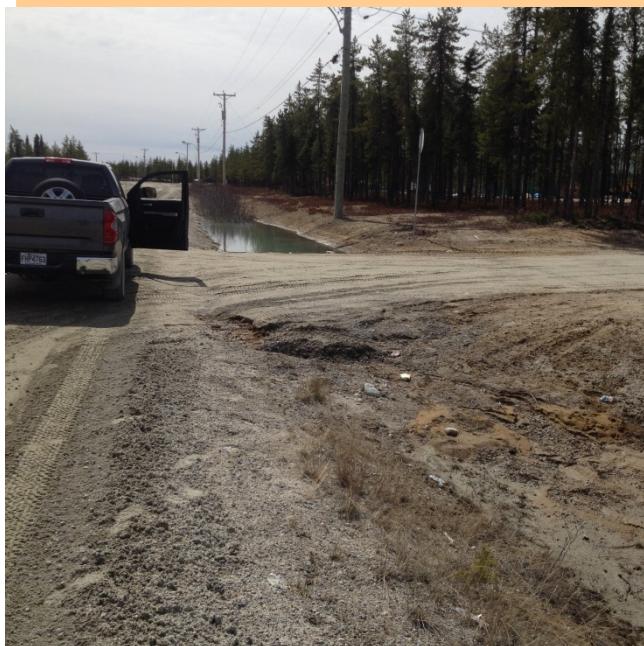
Near the Community, at station 0+300 – see **photo 17** – an entrance to the municipal garage was recently put in without a culvert, resulting in standing water in the ditch upstream from the entrance. We recommend that a 600 mm diameter HDPE culvert be installed and that the ditch be reshaped at the discharge based on the depth of the culvert.

Photo 17: 0+450 east – Municipal garage laneway

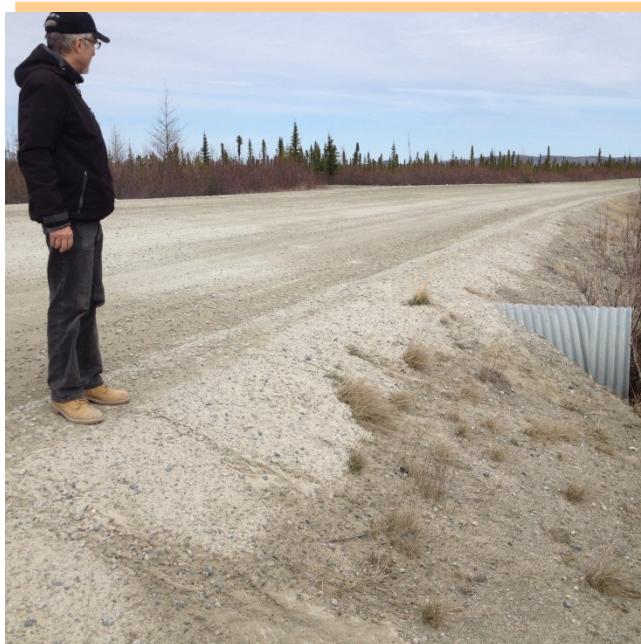
At station 1+190 – **photo 15** – in a curve, a GCSP 900 mm culvert is very thinly covered on the right (west) side of the road. The culvert is not damaged and is bearing traffic loads. The situation will be improved by resurfacing the road with an MG-112 subgrade layer 300 mm thick and a MG-20 granular layer 200 mm thick and paving. During the design phase, we will be able to consider the possibility of further improving this area by granular resurfacing with MG-20.

Photo 15: GCSP 900 at 1+190 – Very thin cover on west side

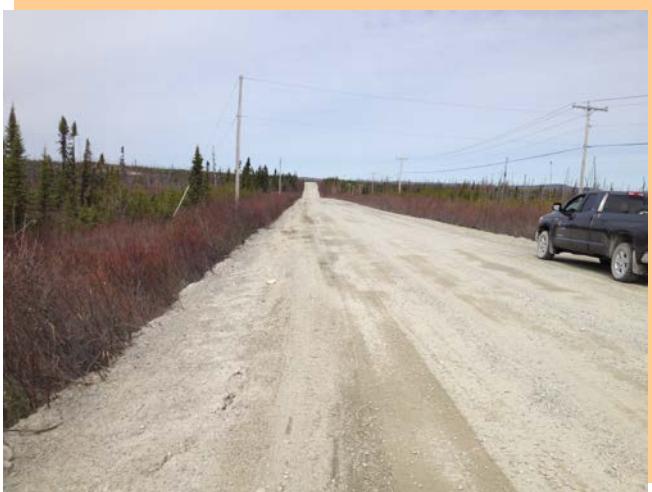
Photo 04: General – Soft shoulders

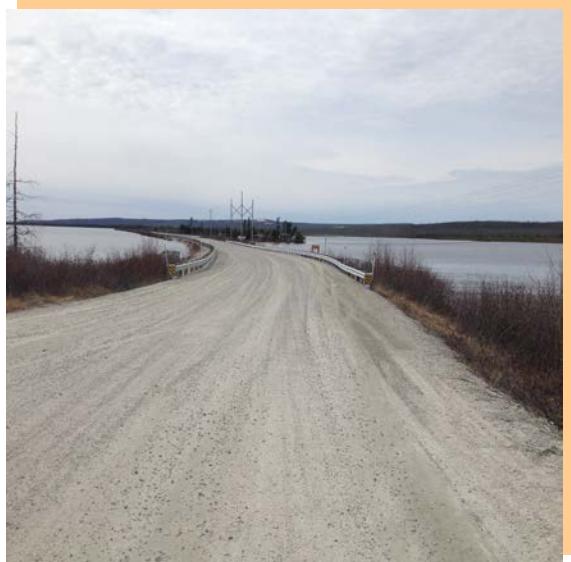
Photo 14: Guardrails 3+400

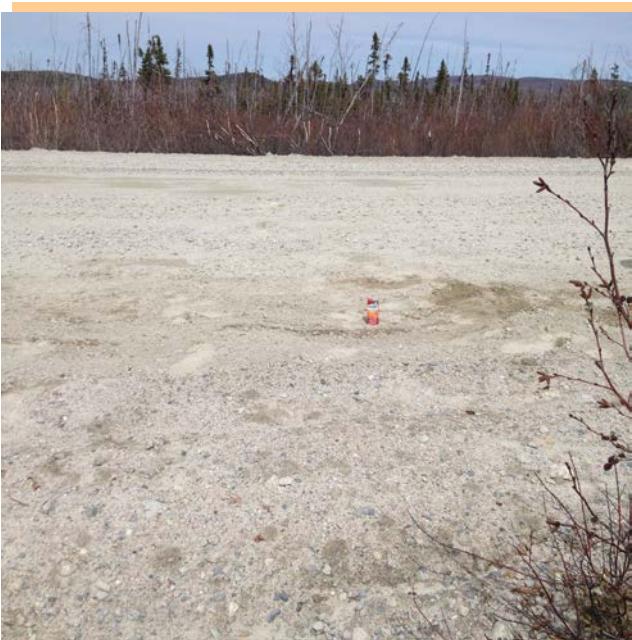
In some places the MG-20 granular material has completely disappeared, and vehicles travel on the coarse aggregate sub-base – see **photo 20**. On both sides the area of displaced MG-20 aggregate is about 2 m wide, but this surface cannot bear traffic. The actual width of the road is about 8 m. In order to ensure satisfactory frost behaviour of the planned road and the structural capacity required for the volume of local heavy traffic, the geotechnical study recommends the following road structure:

Photo 20: 4+500 Sub-base Course aggregate – Surface

- Asphalt: 120 mm;
 - Surface layer ESG-10: 50 mm;
 - Base layer ESG-14: 70 mm.
- Granular sub-base: 200 mm, MG-20;
- Subgrade: 250 mm, MG-112.

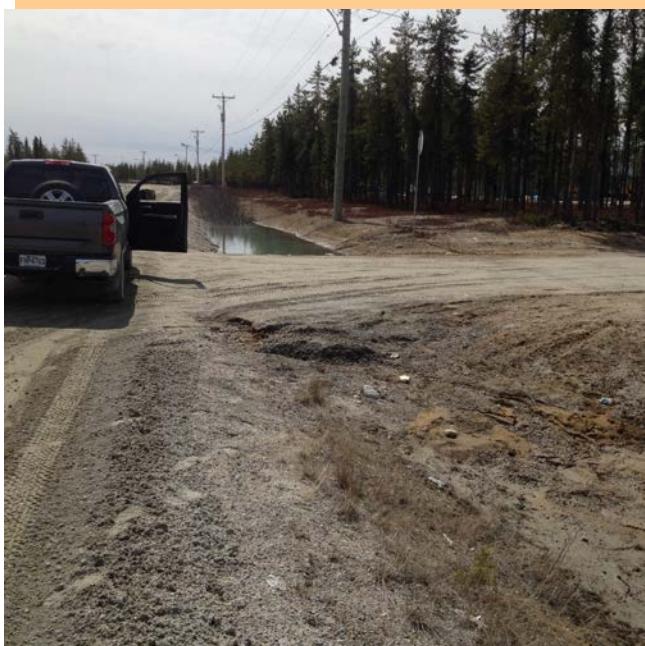
Near the Community, at station 0+300 – see **photo 17** – an entrance to the municipal garage was recently put in without a culvert, resulting in standing water in the ditch upstream from the entrance. We recommend that a 600 mm diameter HDPE culvert be installed and that the ditch be reshaped at the discharge based on the depth of the culvert.

Photo 17: 0+450 east – Municipal garage laneway

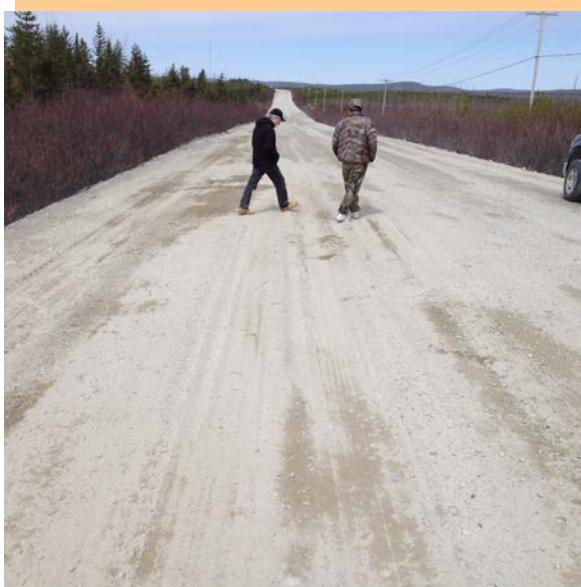
Three depressions were noted within a 900 m section between stations 8+100 and 8+950, and three areas of soft soil were noted in a peat bog section (see Table 3). Owing to a defective road structure, these sections show major deformation, which must be corrected prior to paving.

Photo 10: Depression – 1+420

To rehabilitate the road structure, surface-to-surface transition is required with a longitudinal slope of 1:20, which involves excavating to a depth of 2.2 m (depth of frost) and backfilling with a controlled fill composed of frost-resistant materials up to the infrastructure line, which will eventually be backfilled with MG-112 granular subgrade to a thickness of 600 mm and an MG-20 granular or crushed stone sub-base to a thickness of 300 mm.

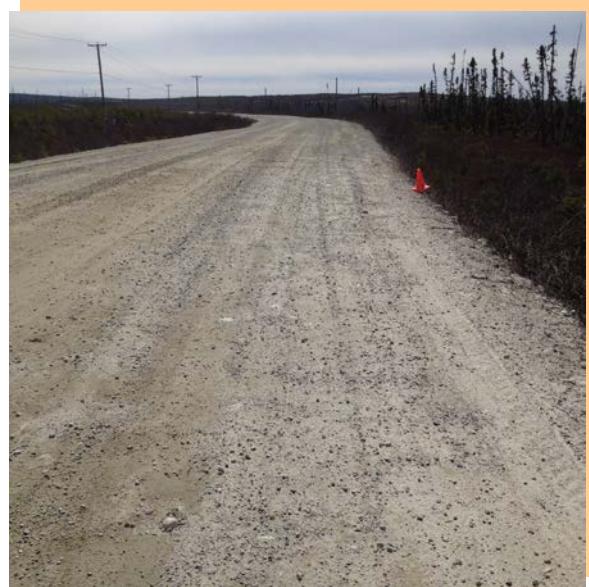
Photo 11: Very soft area between curves – 5+750

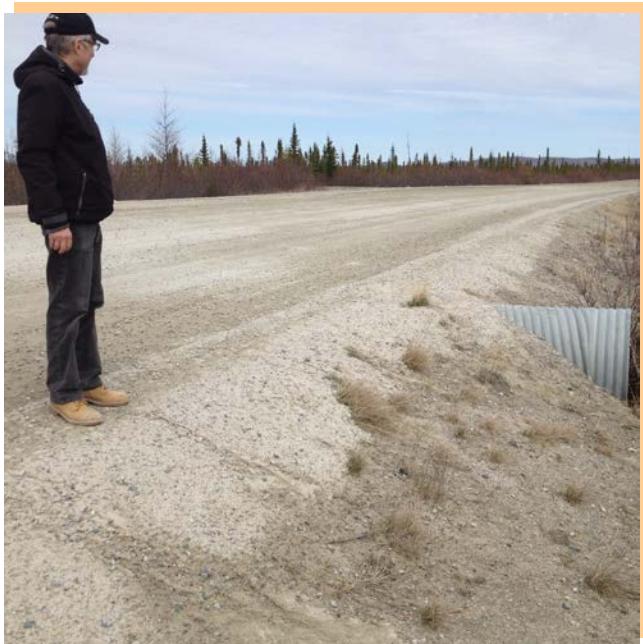
At station 1+190 – **photo 15** – in a curve, a GCSP 900 mm culvert is very thinly covered on the right (west) side of the road. The culvert is not damaged and is bearing traffic loads. The situation will be improved by resurfacing the road with an MG-112 subgrade layer 300 mm thick and a MG-20 granular layer 200 mm thick and paving. During the design phase, we will be able to consider the possibility of further improving this area by granular resurfacing with MG-20.

Photo 15: GCSP 900 at 1+190 – Very thin cover on west side

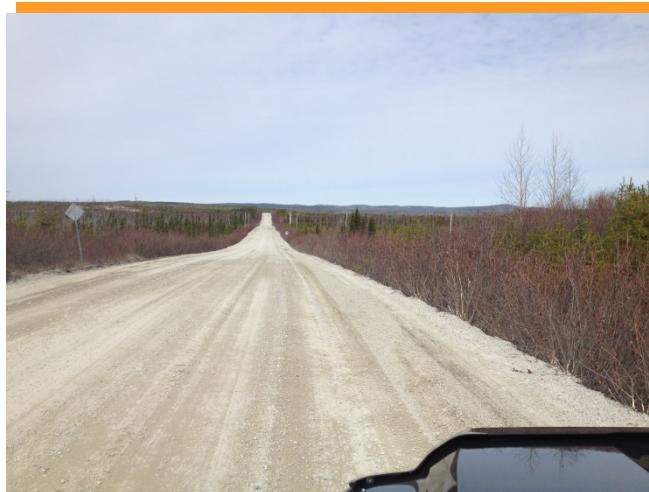
Photo 03: Ditch to be cleaned

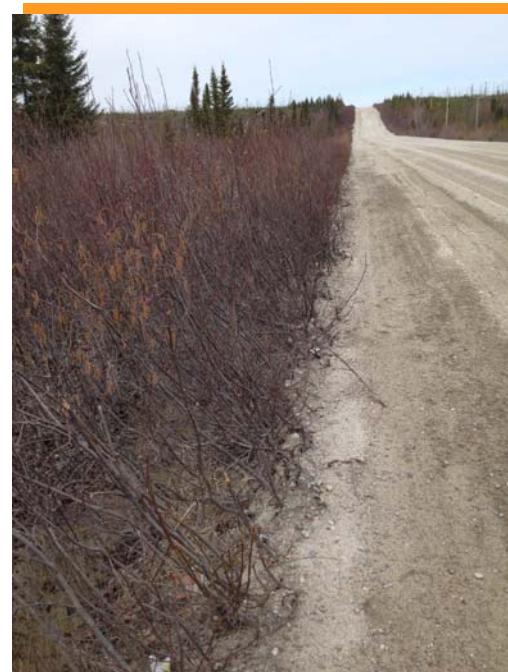
Photo 05: Standing water

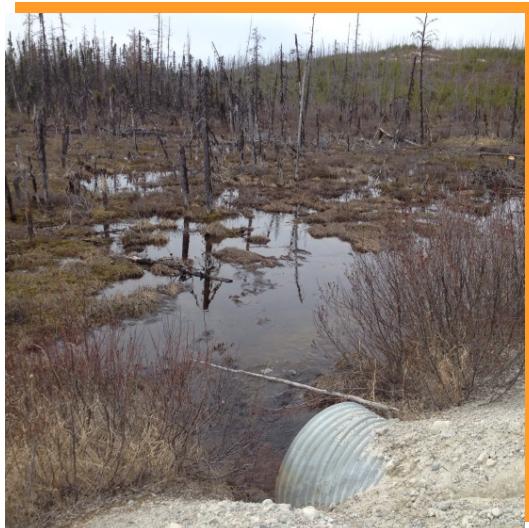
Photo 06: TTOG 1200 9+200 Good condition West

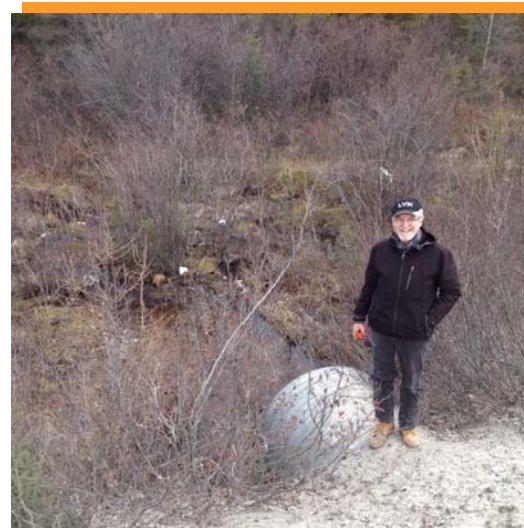
Photo 07: TTOG 1200 9+200 Good condition – East

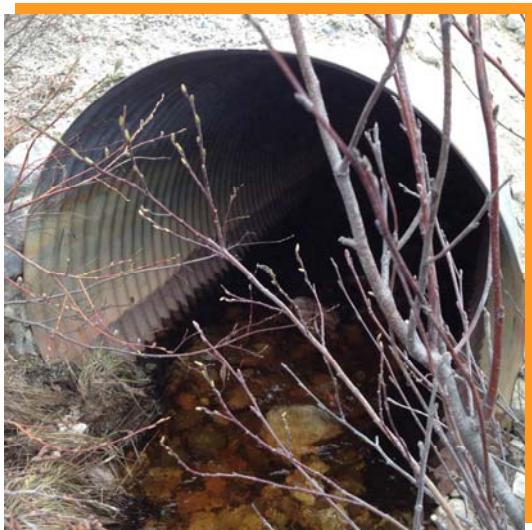
Photo 08: TTOG 1200 9+200 – Good condition inside West

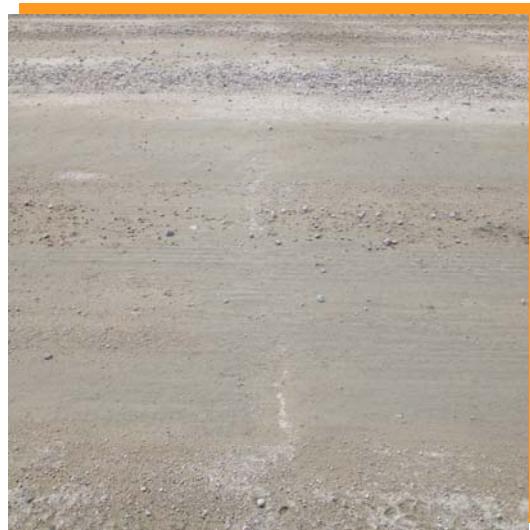
Photo 09: 8+950 –Depression

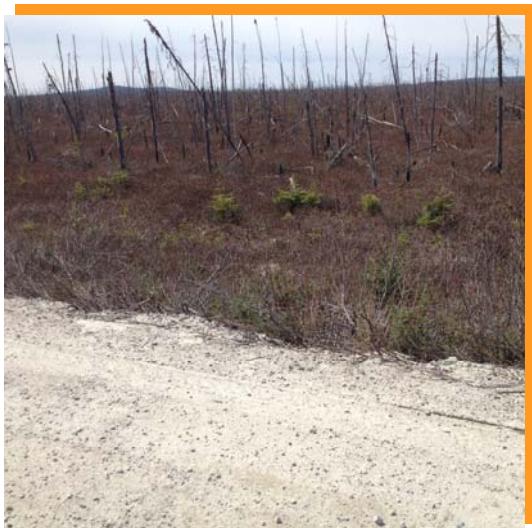
Photo 12: 5+750 – Very soft area

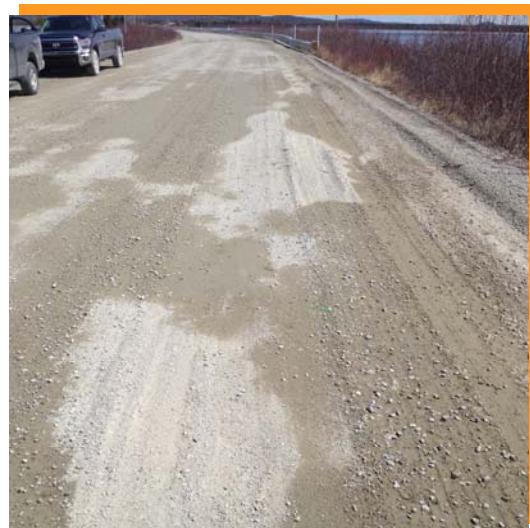
Photo 13: 3+150 – Soft soil

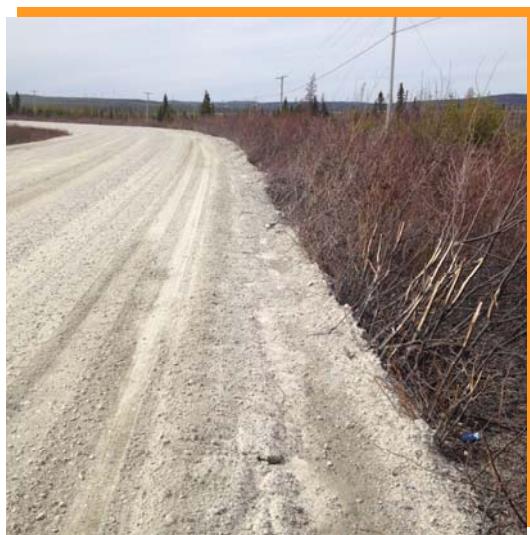
Photo 21: 4+500 – MG-20 Ditch

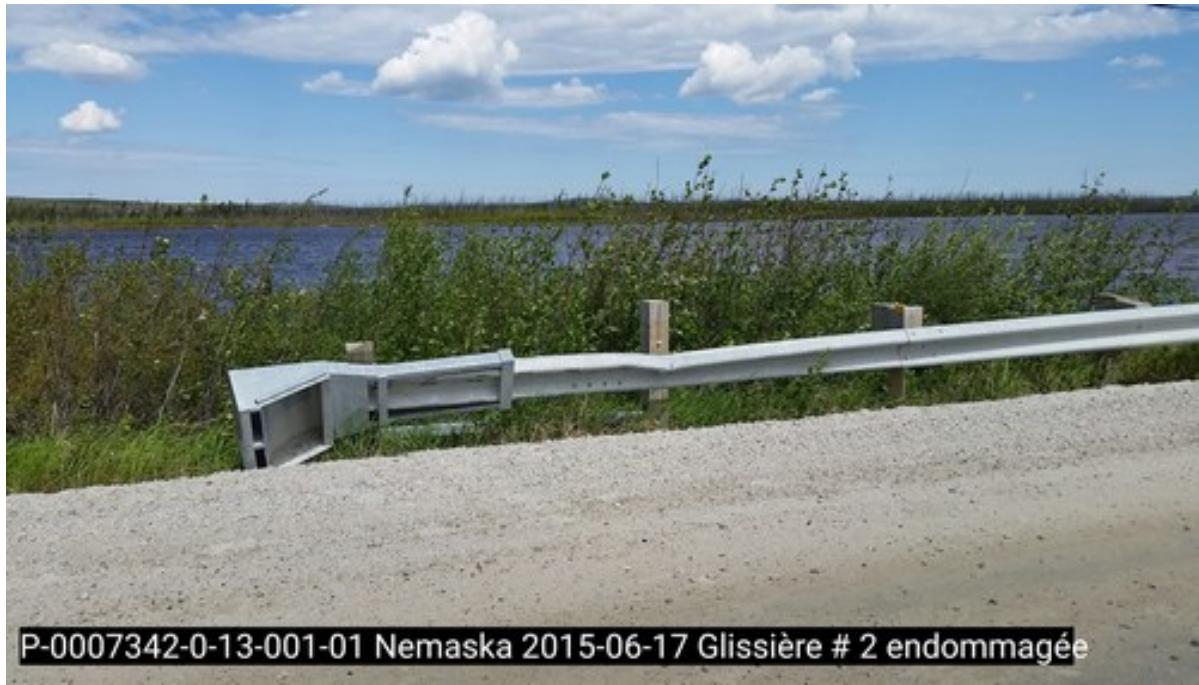
Photo # 2 : Glissières 002

P-0007342-0-13-001-01 Nemaska 2015-06-17 Glissière # 2 endommagée

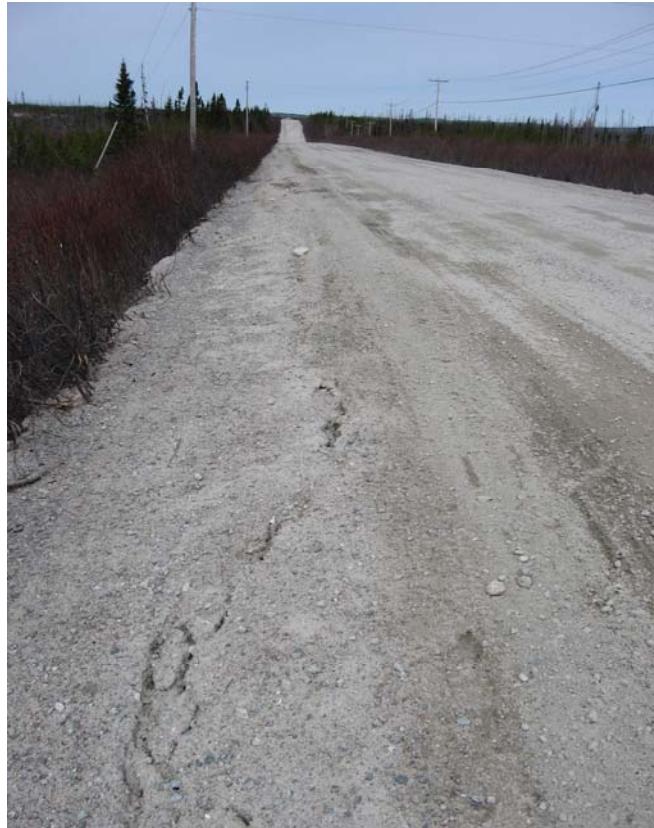
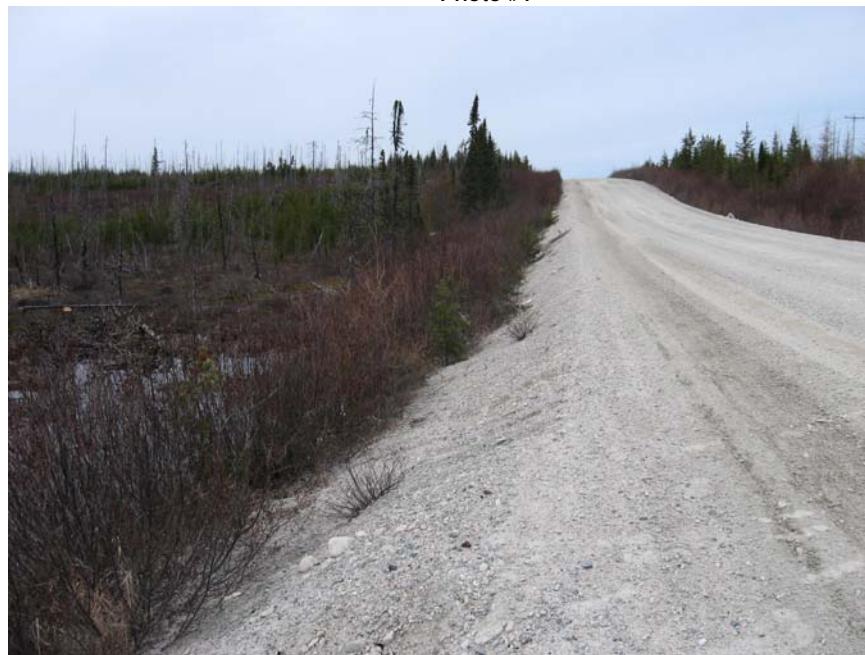
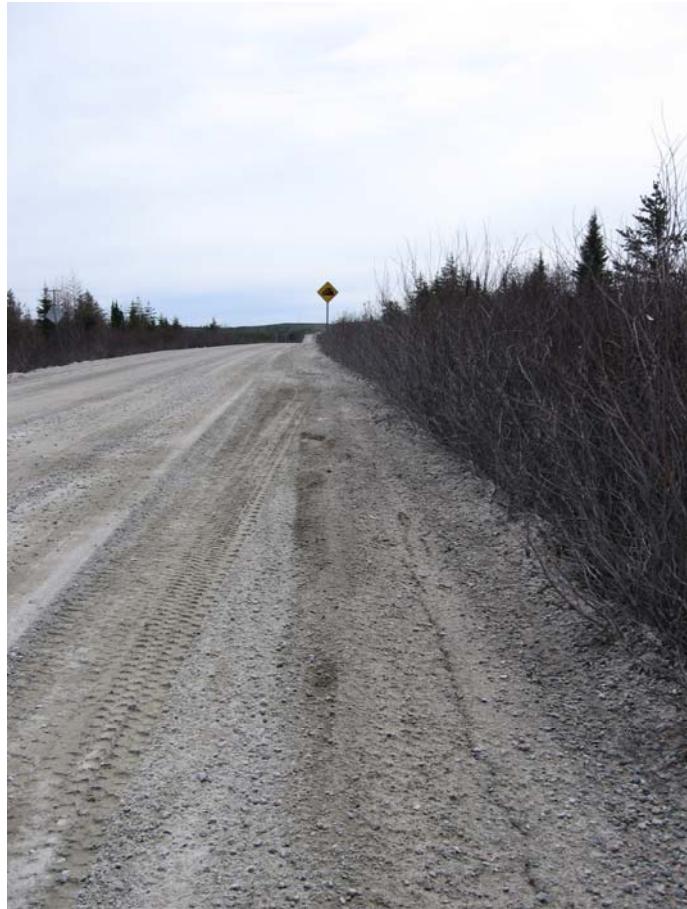
**Annexe 5a Surface instable des
surlargeurs de la chaussée**

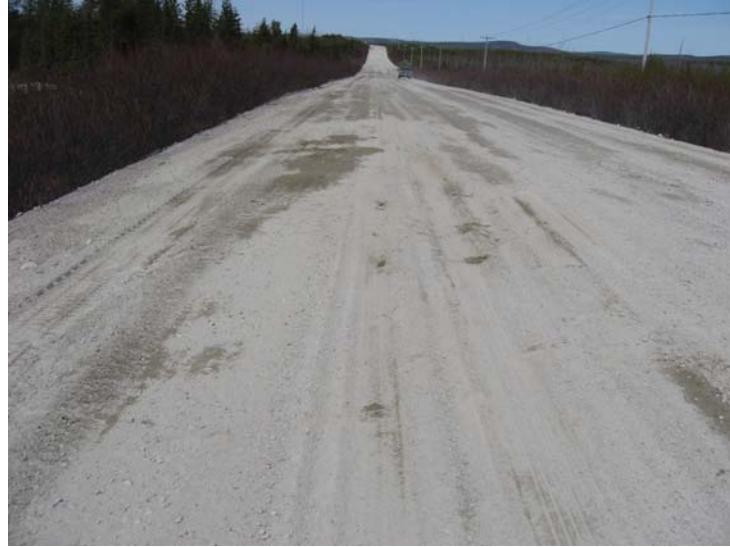
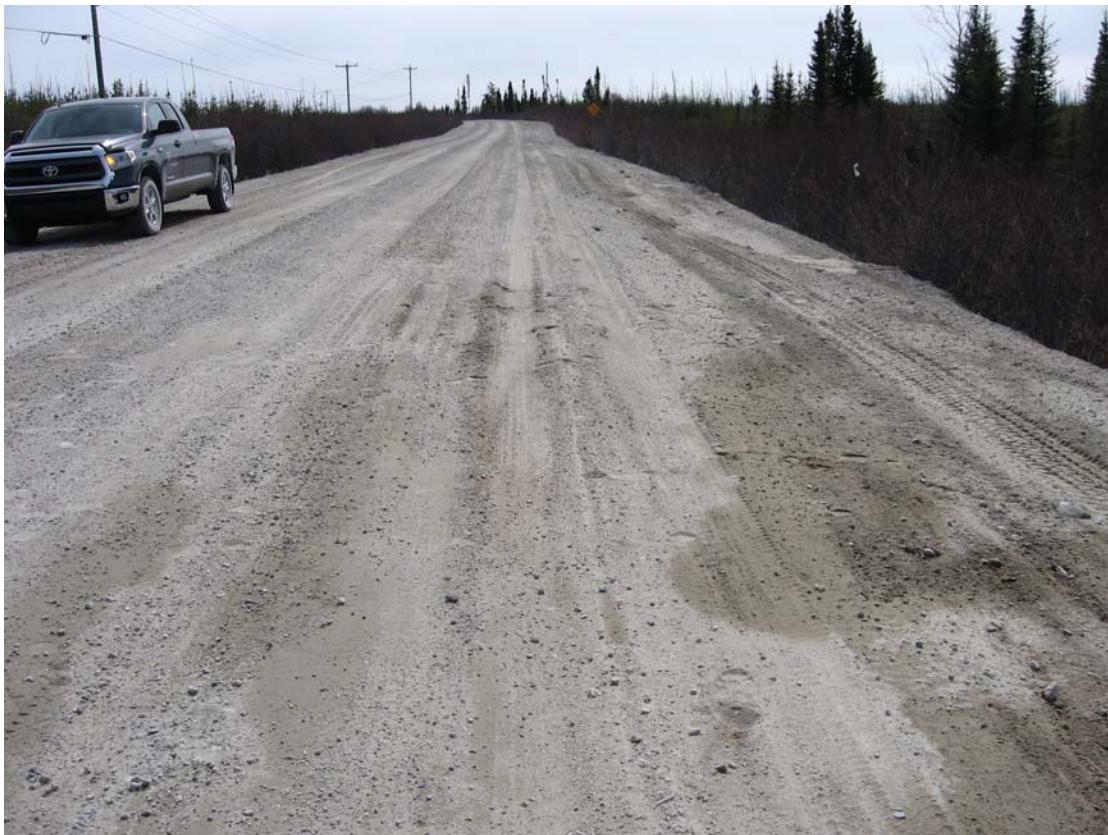
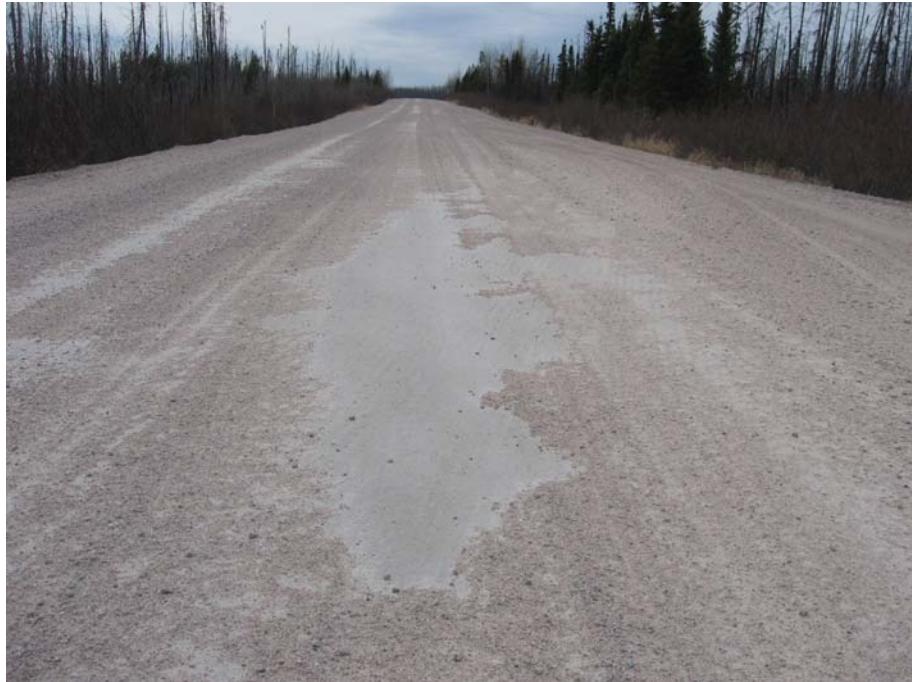
- In 2006 and 2007, new gravel, 100 mm thick, was laid down on the road surface in order to improve the rolling surface. This new gravel is lacking gravel content and is therefore too "sandy". The result of this situation is a road surface that is often soft and unstable, especially after rainy periods. The surface of some localized sections is also glossy, providing poor friction and could therefore be hazardous for the road users;

**Annexe 5b Surface de roulement
déformable et localement
glissante**

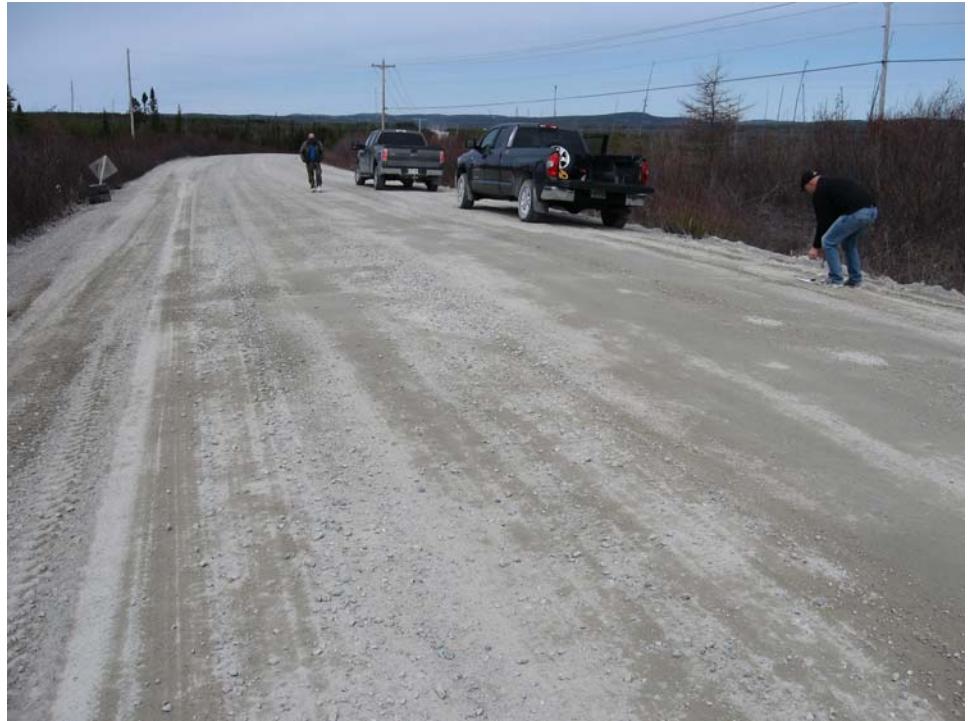
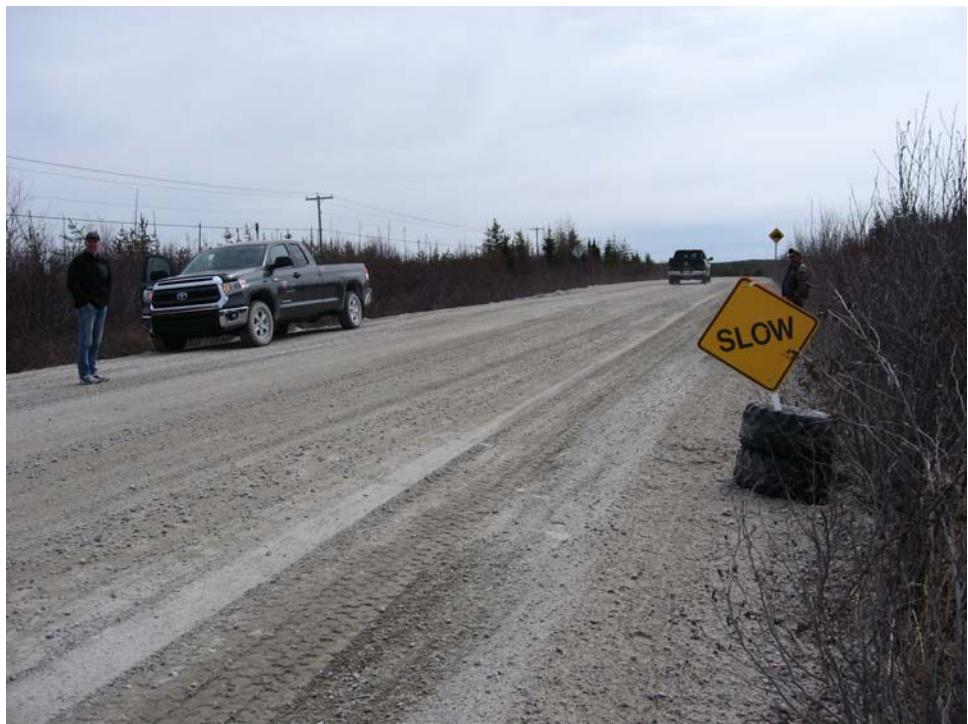
- Localized other deficiencies were also observed, like deformations of the surface, most likely due to frost heave ,at ch. 8+950 and also, between ch. 9+300 and 9+615;
- ▶ On June 17th 2015, 6 boreholes and associated materials sampling were performed with a geotechnical drill;

**Annexe 5c Soulèvement au gel,
chainage 8+950**
