**RESURFACING AND PAVING
OF THE WEMINDJI ACCESS
ROAD-
WEMINDJI (QUÉBEC)**

Environmental Project Notice

157710050-202-105-EN-R0003-00

March 2, 2017

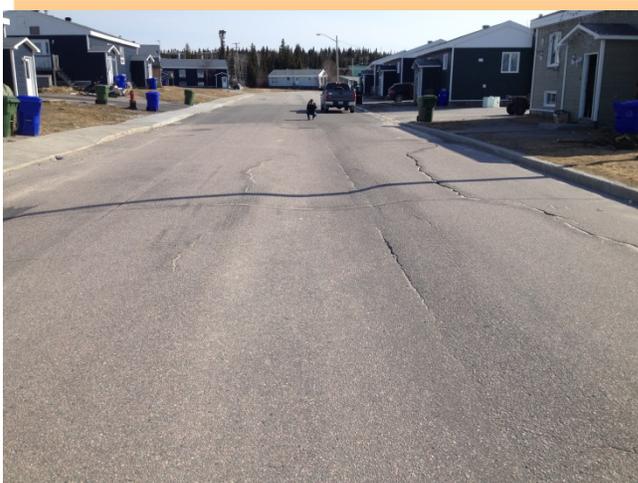
Two severe pavement deformations were observed in the urban area between stations 0+370 and 0+400 and between stations 0+680 and 0+700. Heaving has created depressions and cracks.

Photo 54, between stations 0+370 and 0+400, shows significant deformation, cracking and rutting of approximately 150 mm.

Photo 54: 0+370 to 0+400 Cracking/heaving 150 mm – facing east

In the same sector, as shown in **photo 54**, one section of the road surface was corrected several years ago and the results seem conclusive. The corrective actions taken at the time included excavating approximately 1.2 meters, installing a membrane at the bottom of the cut, rebuilding the pavement structure and asphaltting.

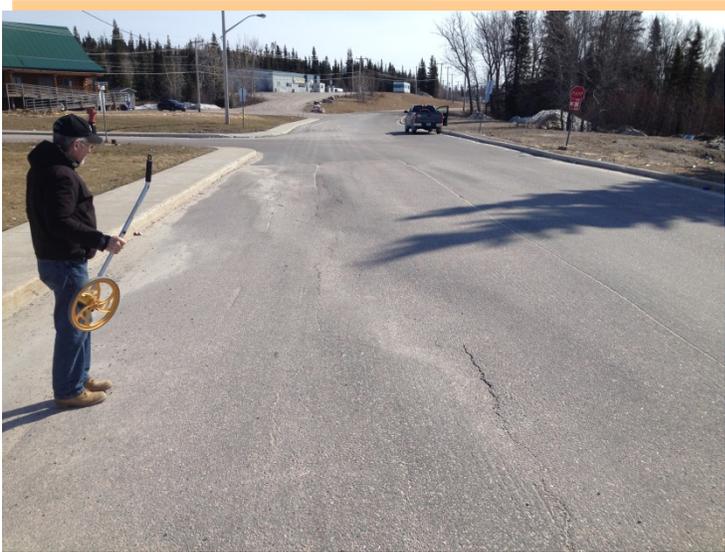
Photo 56, between stations 0+680 and 0+700, shows significant deformation, cracking and rutting of approximately 200 mm.

Photo 56: 0+680 to 0+700 deformations/heaving 200 mm – facing east

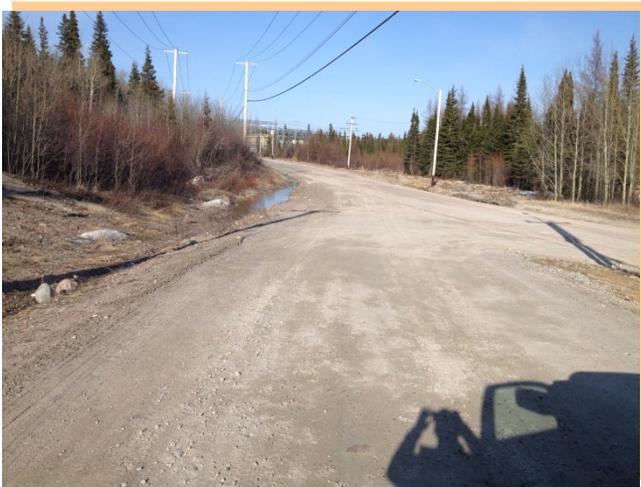
Photo 103 shows water accumulation on the left (north) side of the road stretching almost to the wearing surface. We recommend installing a culvert to drain the water toward the south.

Rock may be found at the location where the culvert is needed, which could be the reason it was never built.

In addition, resurfacing with MG-20 to raise the profile is planned in order to ensure adequate coverage for the proposed culvert.

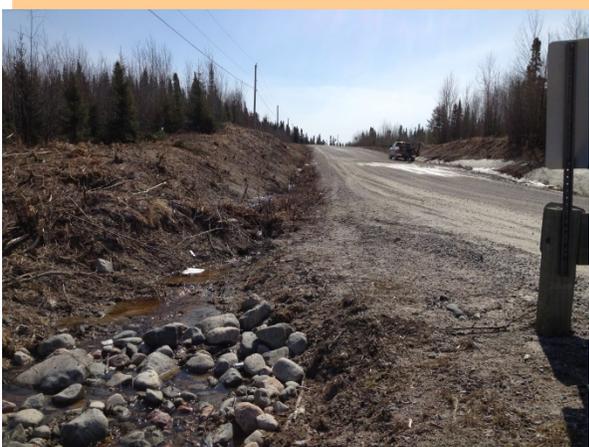
Photo 72 shows a recurrence of a problem that has been observed for a number of years: water flowing continuously on the surface on the right (south) side of the road.

Photo 72: East end of bridge – facing east

The estimate includes creating a transition and replacing excavated materials with porous materials, excavating any rock that may constitute a problem and excavating ditches on both sides of the road over a distance of approximately 150 meters.

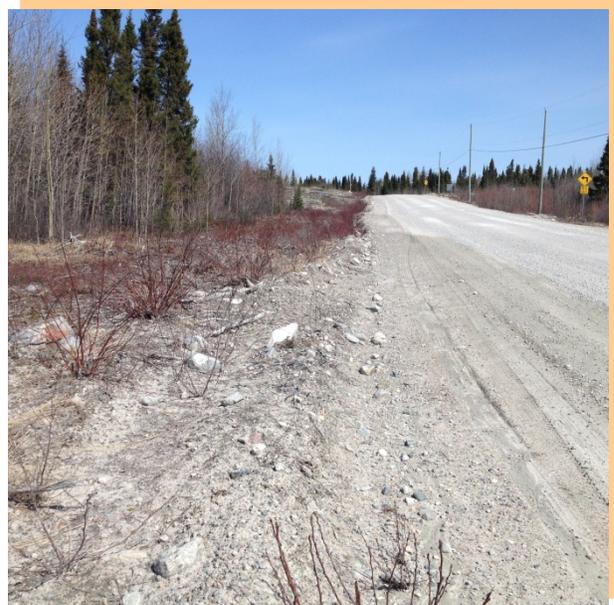
In a number of locations, we noted obvious drainage problems, either there were no ditches at all or, for example, the granular materials in the berms prevented water from flowing away from the roadbed.

Photo 75: 3+700 to 4+100 Berm without ditch R – facing west

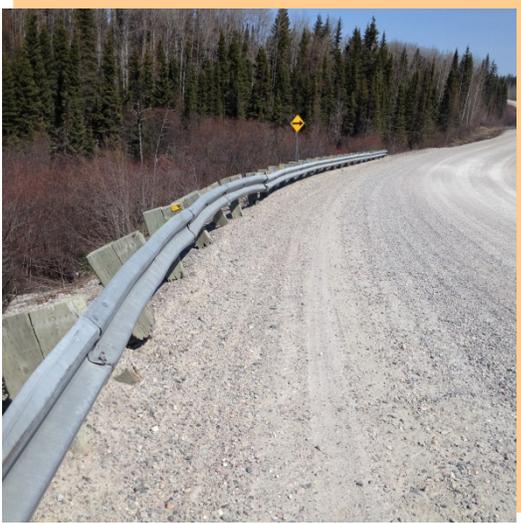
Photo 81 shows damage to the guardrail near station 4+200. Corrective work is required to ensure the safety of users in this sector. Seven wooden posts and three guardrail sections need to be replaced.

Photo 81: 4+220 Guardrails to be repaired

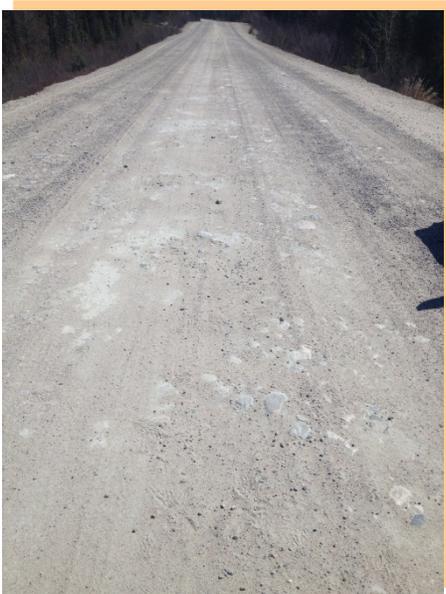
In several locations, for example at station 12+000 (**photo 89**), the wearing surface MG-20 has completely disappeared leaving the sub-base exposed. An aggregate overlay of 200 mm of MG-20 is required to restore and maintain the granular surface prior to paving.

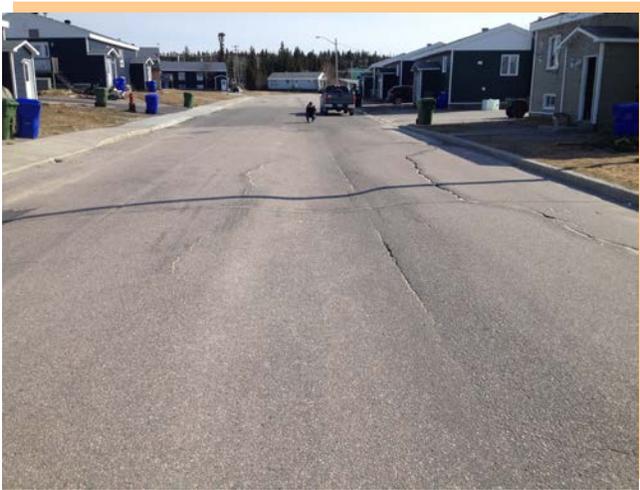
Photo 54, between stations 0+370 and 0+400, shows significant deformation, cracking and rutting of approximately 150 mm.

Photo 54: 0+370 to 0+400 Cracking/heaving 150 mm – facing east

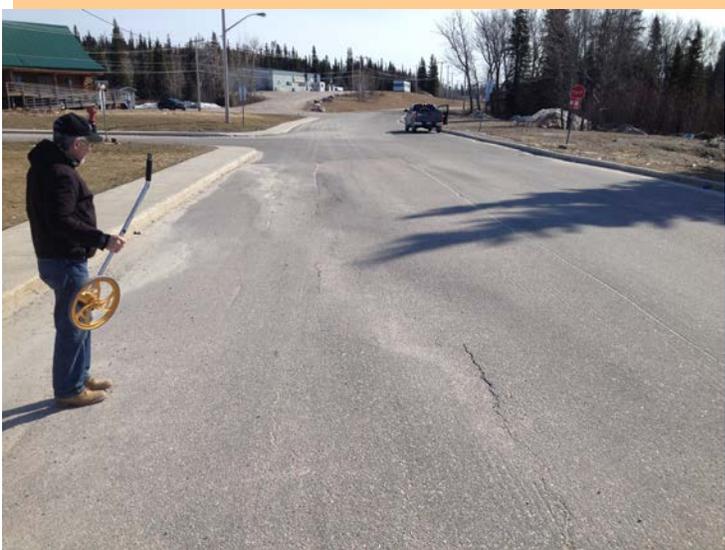
Photo 56, between stations 0+680 and 0+700, shows significant deformation, cracking and rutting of approximately 200 mm.

Photo 56: 0+680 to 0+700 deformations/heaving 200 mm – facing east

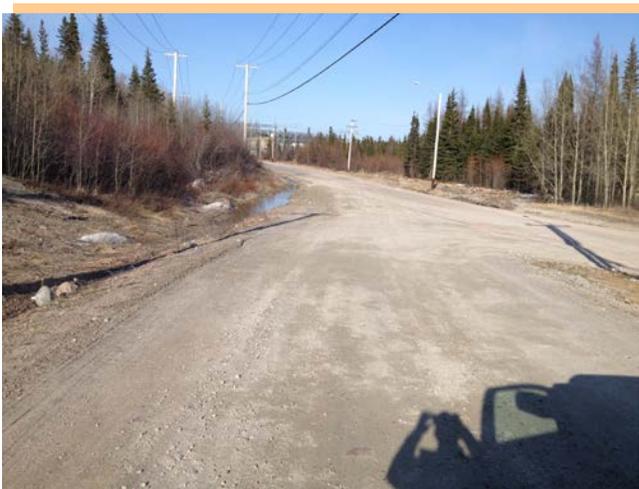
Rock may be found at the location where the culvert is needed, which could be the reason it was never built.

Photo 103: Culvert to be installed at gas station entrance

In addition, resurfacing with MG-20 to raise the profile is planned in order to ensure adequate coverage for the proposed culvert.

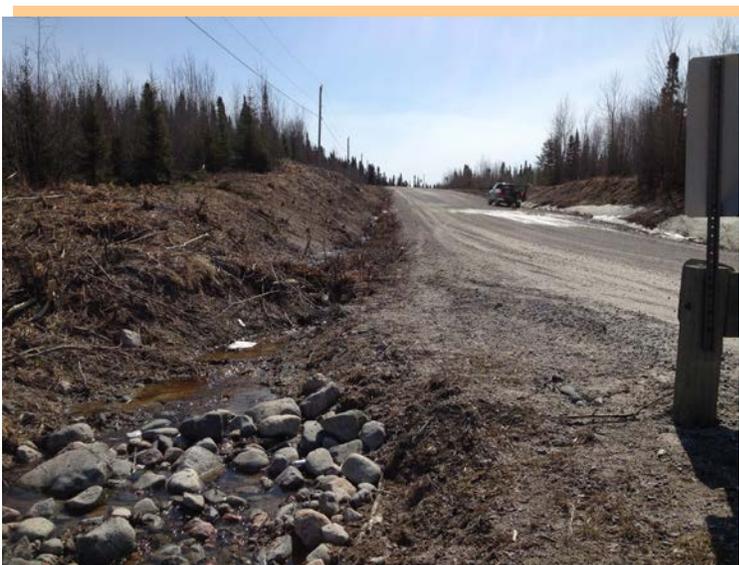
Photo 72 shows a recurrence of a problem that has been observed for a number of years: water flowing continuously on the surface on the right (south) side of the road.

Photo 72: East end of bridge – facing east

The estimate includes creating a transition and replacing excavated materials with porous materials, excavating any rock that may constitute a problem and excavating ditches on both sides of the road over a distance of approximately 150 meters.

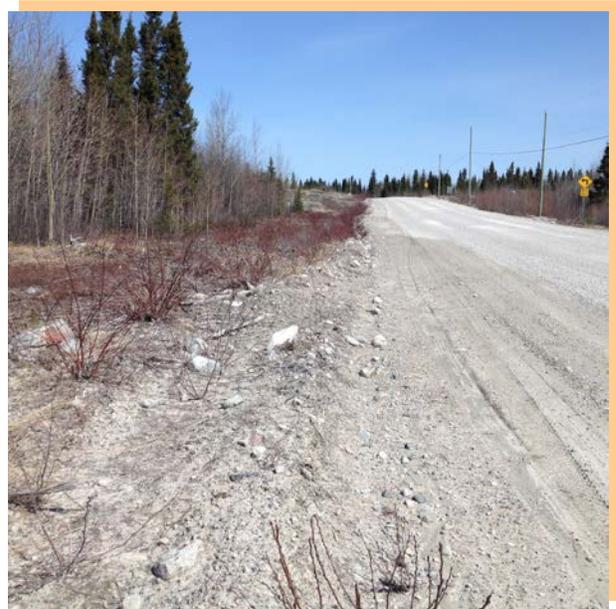
Photo 75: 3+700 to 4+100 Berm without ditch R – facing west

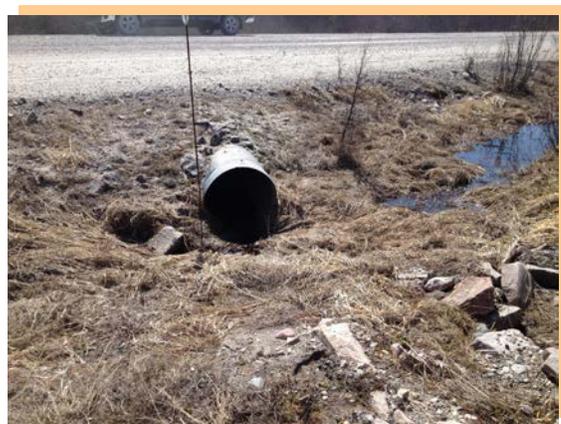
Photo 99: 15+400 TTOG 900 – Inlet clearing required

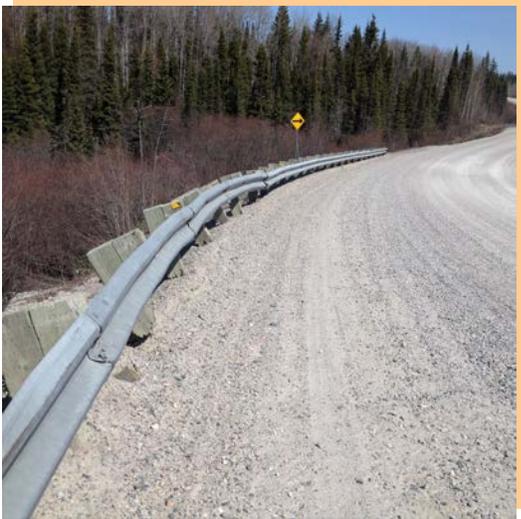
Photo 81 shows damage to the guardrail near station 4+200. Corrective work is required to ensure the safety of users in this sector. Seven wooden posts and three guardrail sections need to be replaced.

Photo 81: 4+220 Guardrails to be repaired

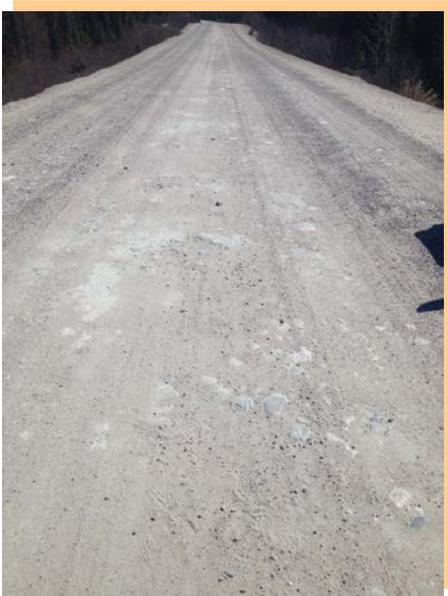
In several locations, for example at station 12+000 (**photo 89**), the wearing surface MG-20 has completely disappeared leaving the sub-base exposed. An aggregate overlay of 200 mm of MG-20 is required to restore and maintain the granular surface prior to paving.

Photo 89: Exposed MG-112 sub-base

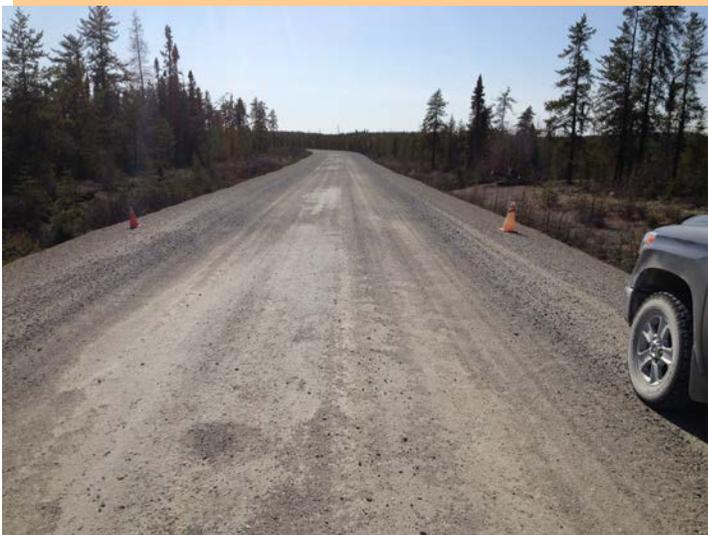
On the road, at station 69+830 (**photo 101**), the cones placed on either side of the road during the visit mark spots of significant deformation due to frost heave. Transition work may be required prior to paving.

Photo 101: 69+830 MTQ Frost heave deformation – facing east

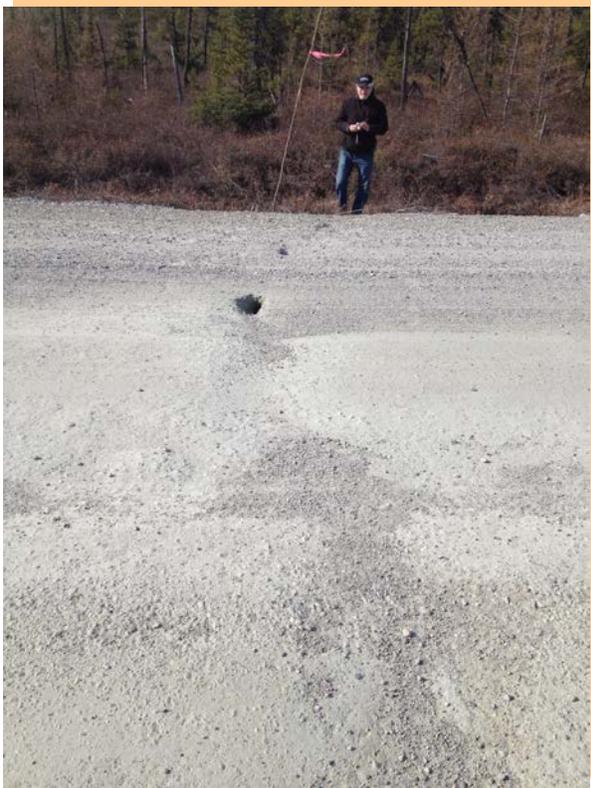
On the road, at station 82+250 (**photo 102**) and at station 82+770, red tape was placed on either side of the road to mark the locations of large frost cracks. Transition work may be required prior to paving.

Photo 102: 82+500 MTQ Transverse frost heave crack – facing north

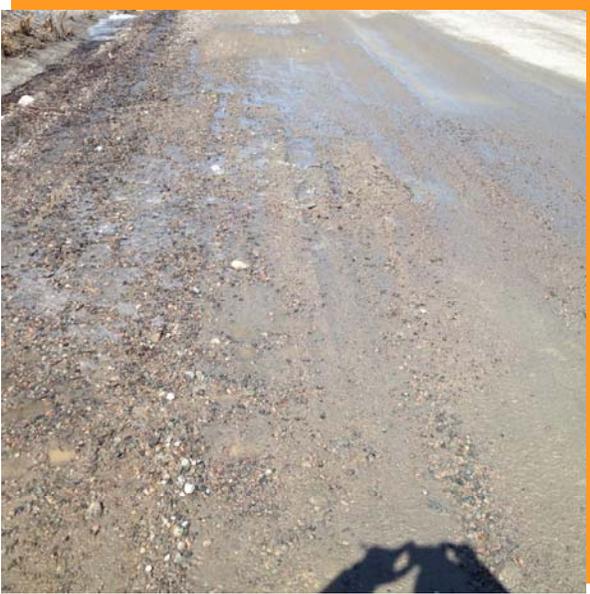
Photo 74: 3+100 - Upwelling of water to the surface, right

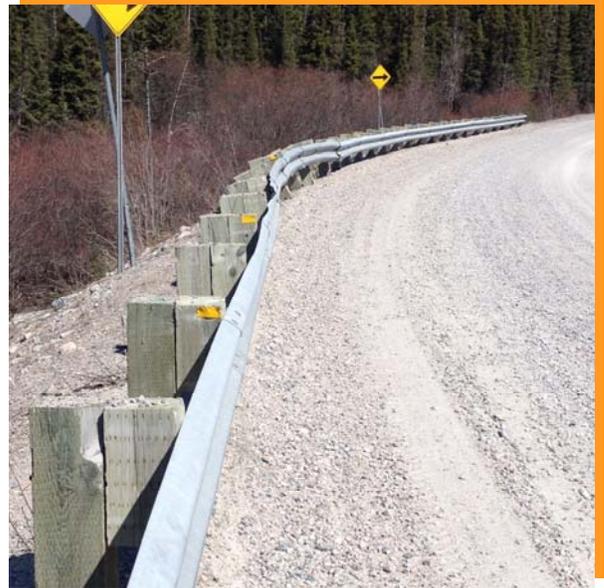
Photo 79: 4+220 – Guardrail to repair

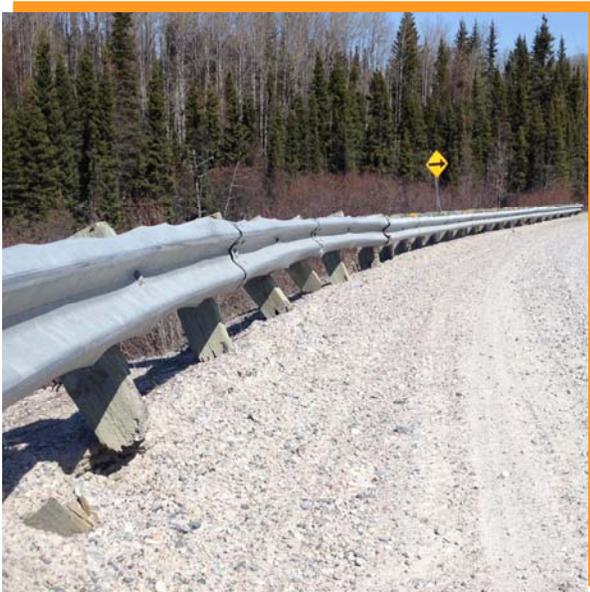
Photo 80: 4+220 – Guardrail to repair

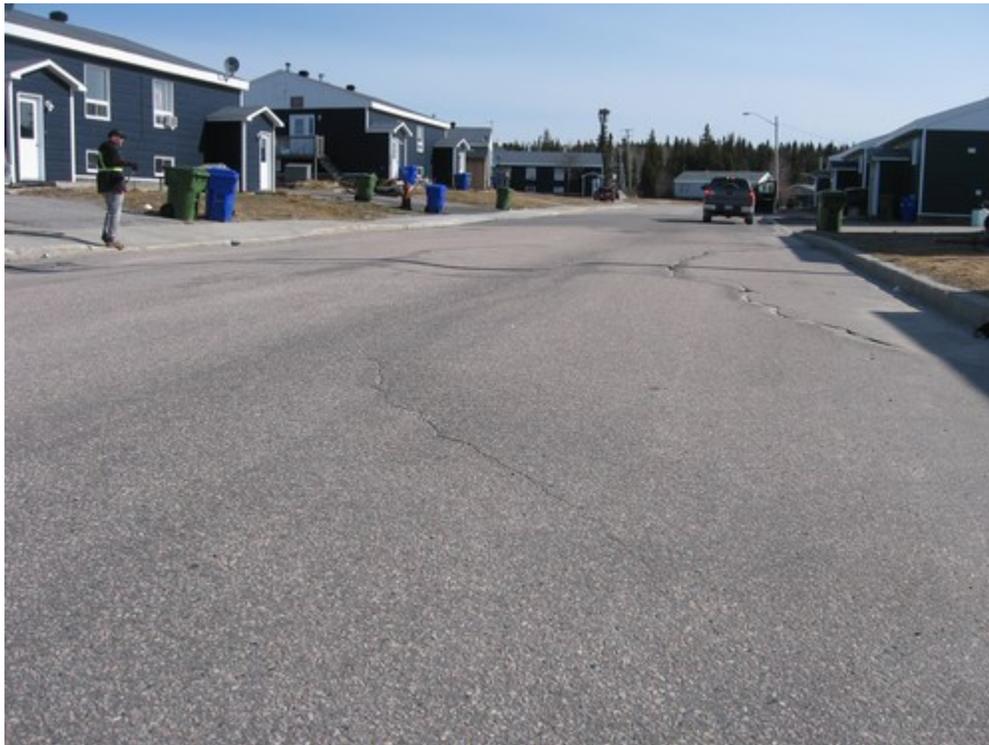
Photo #2 : Déformation_surface_Beaver_Road

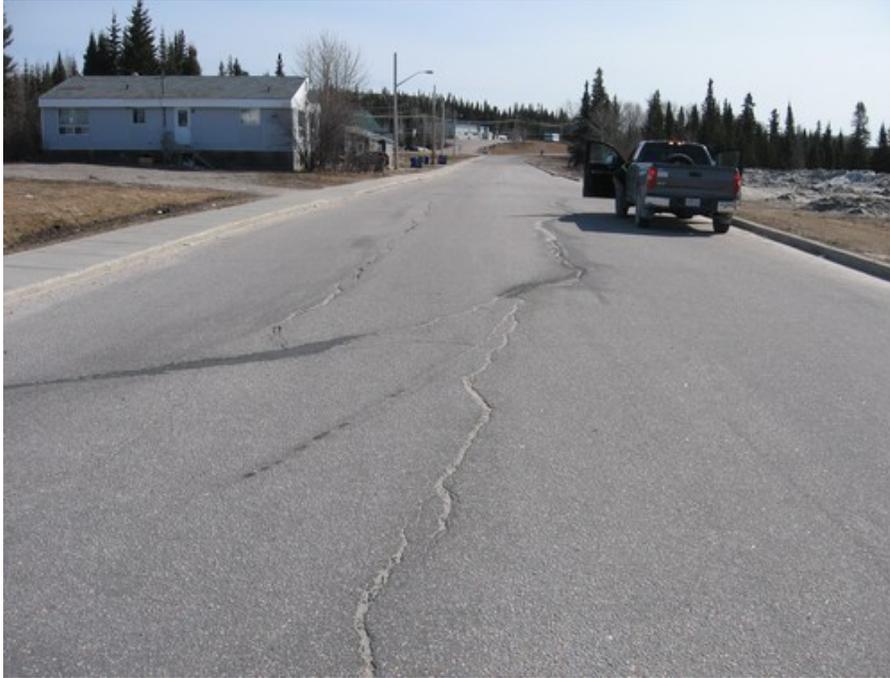
Photo #3 : Déformation_surface_Beaver_Road

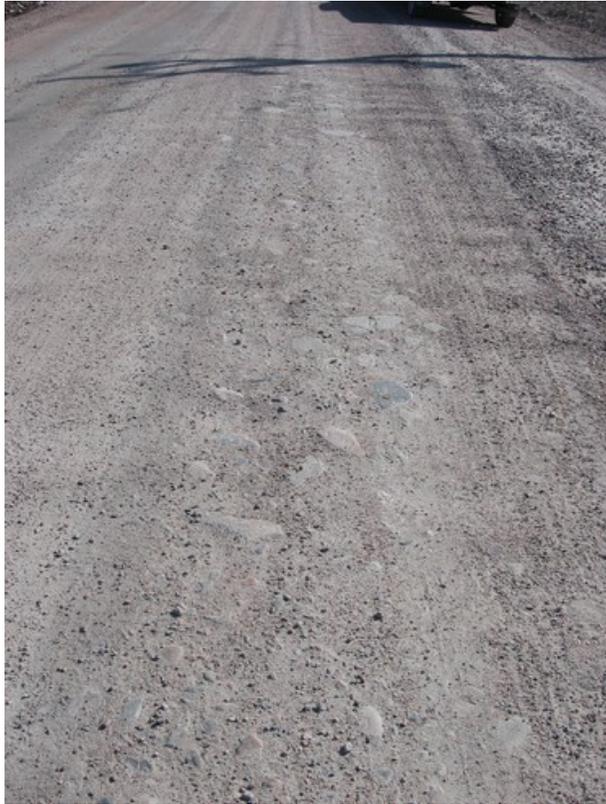
Photo #5 : Érosion_surface_gravelée

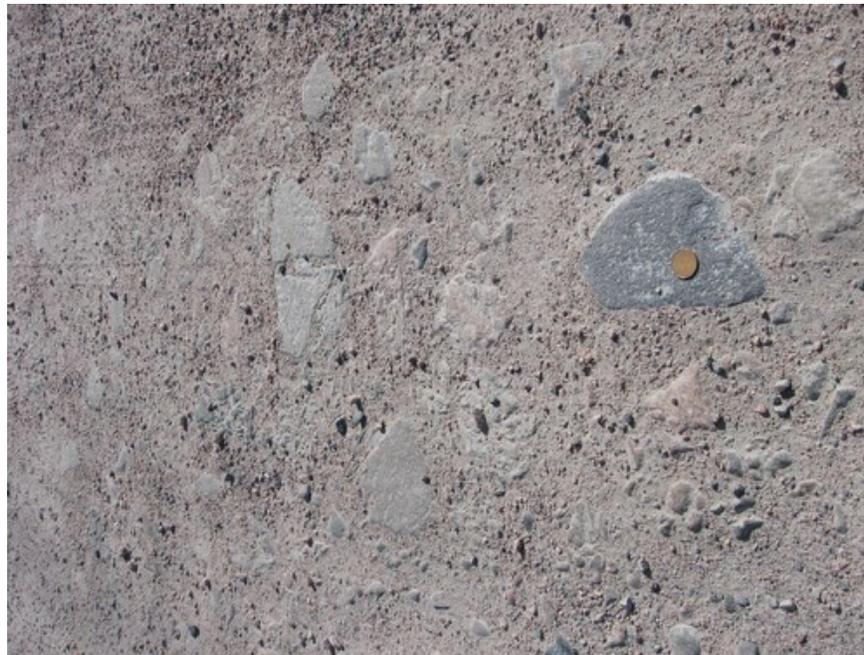
Photo #6 : Érosion_surface_gravelée

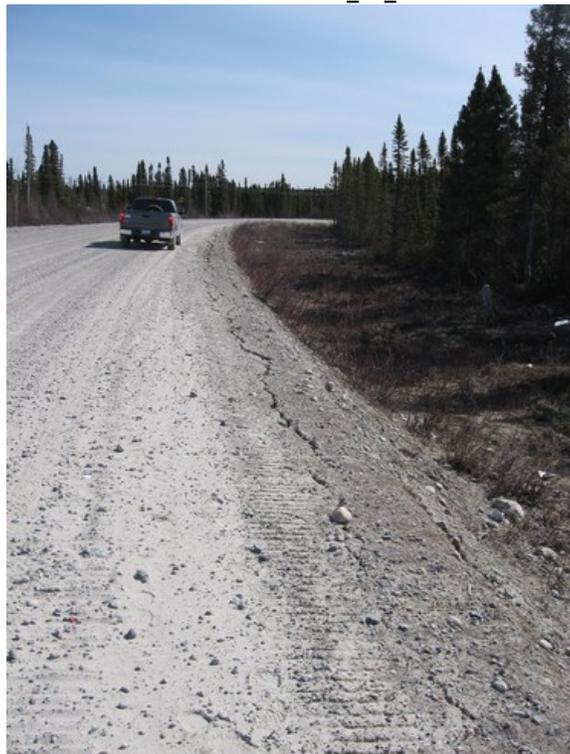
Photo #8 : Instabilité_rives

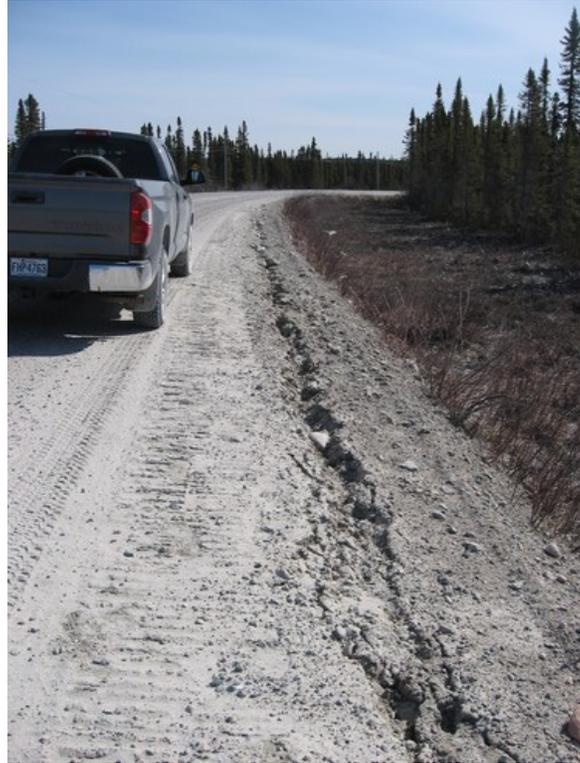
Photo #9 : Instabilité_rives

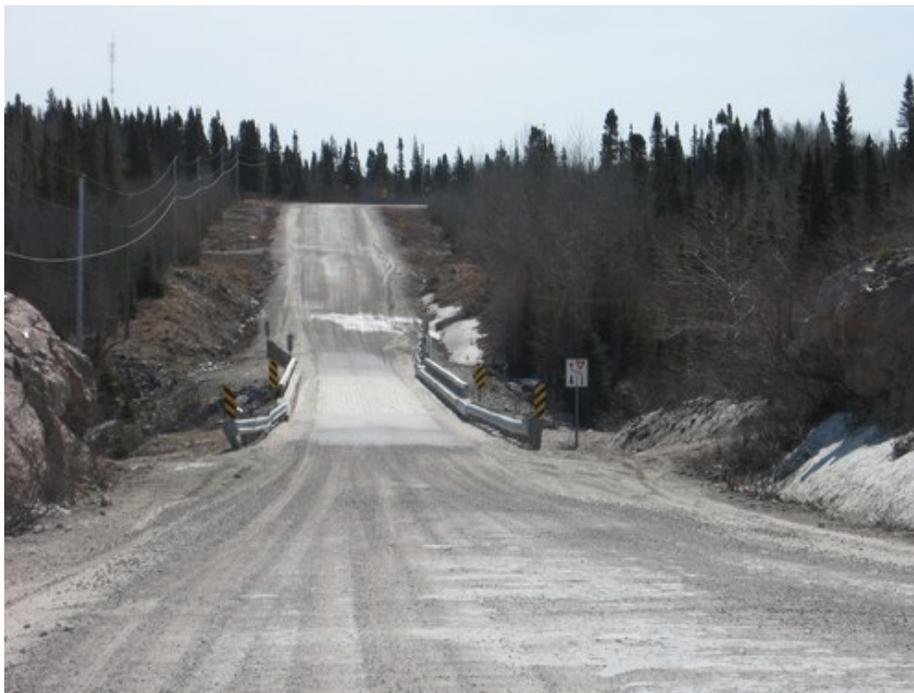
Photo #10 : Resurgence_ch3+100

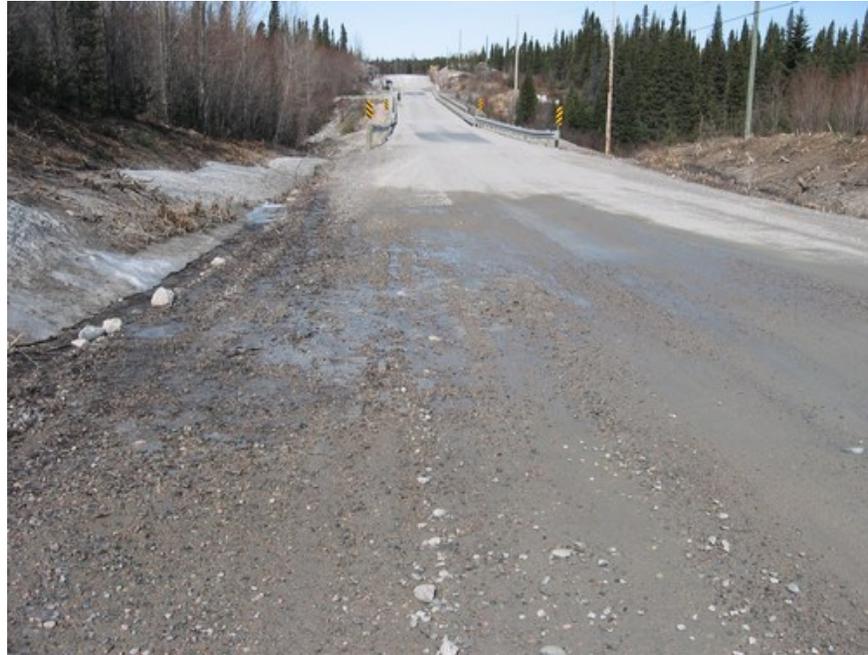
Photo #11 : Resurgence_ch3+100

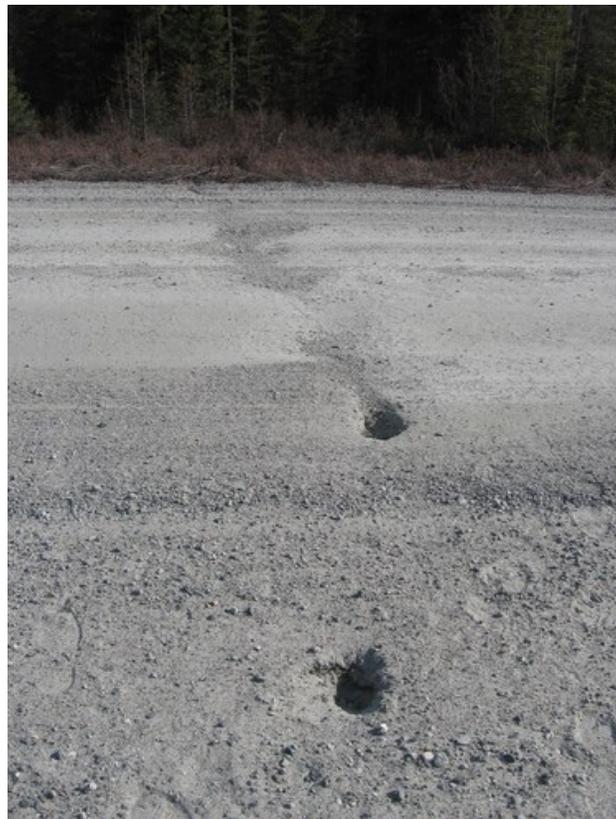
Photo #12 : Fissure-gel_82+250
