Site 403A

Site 406A

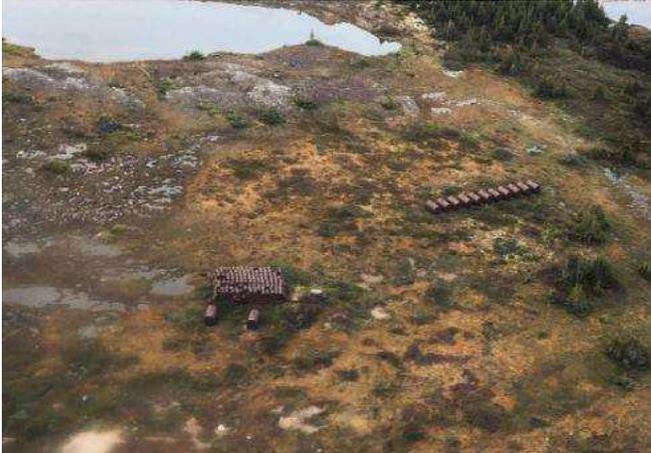
The site is located on the edge of Hudson Bay, 34 km southwest of Kuujjuarapik. The site is accessible by snowmobile, VTT, boat or by air (helicopter). The equipment in place includes a main fuel tank farm of 11 tanks and another secondary of 2 all empty above-ground tanks with a capacity of 4 400 liters each still in place, the associated pumping and pipeline system, an empty barrel storage area totaling about 375 barrels as well as 2 half-filled barrels containing liquid (probable tar) and some areas of various debris. There is no existing path connecting the site to the main site, to Kuujjuarapik or to the Trans-taiga road. The equipment is visible in flight. Surface deposits are mainly composed of sand (usually less than 0.35 m thick) and rests on pebbles or blocks in places followed by natural rock.

- Soils with concentrations above criterion B_{ecotox} in PH C₁₀-C₅₀ are present on the site at the location of one area. The volume of these soils is estimated at 1.3 m³ which have in the concentration $B_{ecotox-C}$.
- The area affected by the contamination is the main tank farm and pipeline area.
- Surface water has concentrations of PAHs, PH C₁₀-C₅₀ and metals below the criterion for the protection of acute aquatic life.
- The inventory of structures and debris present on the site has made it possible to estimate a volume of 102 m³ of material of which 97 m³ are residual material and 5 m³ are residual dangerous material or asbestos-containing materials.

The following assessment considers that the present infrastructure will be demolished, packaged and transported off-site. After removal of the residual material and residual dangerous material, a characterization of the underlying soils will be carried out to determine the rehabilitation needs. Soils with a level of contamination above criterion B_{ecotox} will be excavated and transported offsite. Air transport by helicopter was considered up to the exit point of Kuujjuarapik. From there the material will be transported by barge to Chisasibi and finally transported by land to authorized treatment, recycling or disposal sites. Other rehabilitation and transport alternatives are also possible.

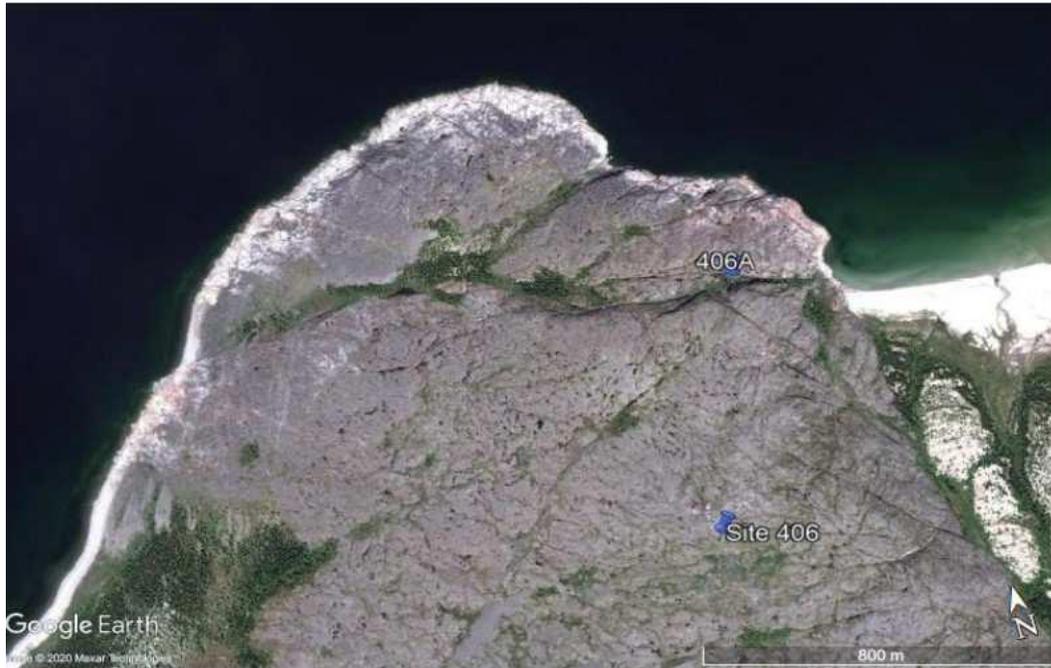
The site is located on the edge of Hudson Bay, 95 km southwest of Kuujjuarapik on a rocky massif with 100 meters of altitude. The site is accessible by VTT, boat or by air (helicopter). The equipment in place includes a tank farm of 4 empty above-ground tanks with a capacity of 4400 liters each still in place, the pumping system installed in a building for this purpose, a pipeline connecting the radar station 406 located 600 meters away, a few empty barrels, an old compressor and some areas of various debris. There is no existing path connecting the site to the main site, to Kuujjuarapik or to the Trans-taiga road. The equipment is visible in flight. The site includes rocky outcrops, the presence of contaminated soils is considered in the rock depressions which are also preferential paths for anthropogenic surface contamination.

- The soils located on the rock are in very small quantities.
- The inventory of structures and debris present on the site has made it possible to estimate a volume of 50 m³ of residual material of which 5 m³ are residual material and 45 m³ are residual dangerous materials or containing asbestos.

The following assessment considers that the present infrastructure will be demolished, packaged and transported off-site. After removal of the residual material and residual dangerous material, a characterization of the underlying soils will be carried out to determine the rehabilitation needs. Transport will be by air to the Kuujjuarapik exit point. From there it will be transported by barge to Chisasibi and finally transported by land to authorized treatment, recycling or disposal sites. Other rehabilitation and transport alternatives are also possible.
