SUBJECT: APPLICATION FOR A CERTIFICATE OF NON-SUBJECTION FOR THE GD-17 SAND PIT

**Responses to COMEV's Questions and Comments - Nemaska Cree First -Nation GD17 Borrow
Pit Expansion Project
(File 3214-03-046)**

CONSULTATION WITH THE OWNERS OF THE CABINS LOCATED NEAR THE BORROW PIT AND THE TALLYMAN OF THE LOT R-16

CHARACTERIZATION OF NATURAL ENVIRONMENTS OF THE GD-17 GRAVEL PIT, NEMASKA

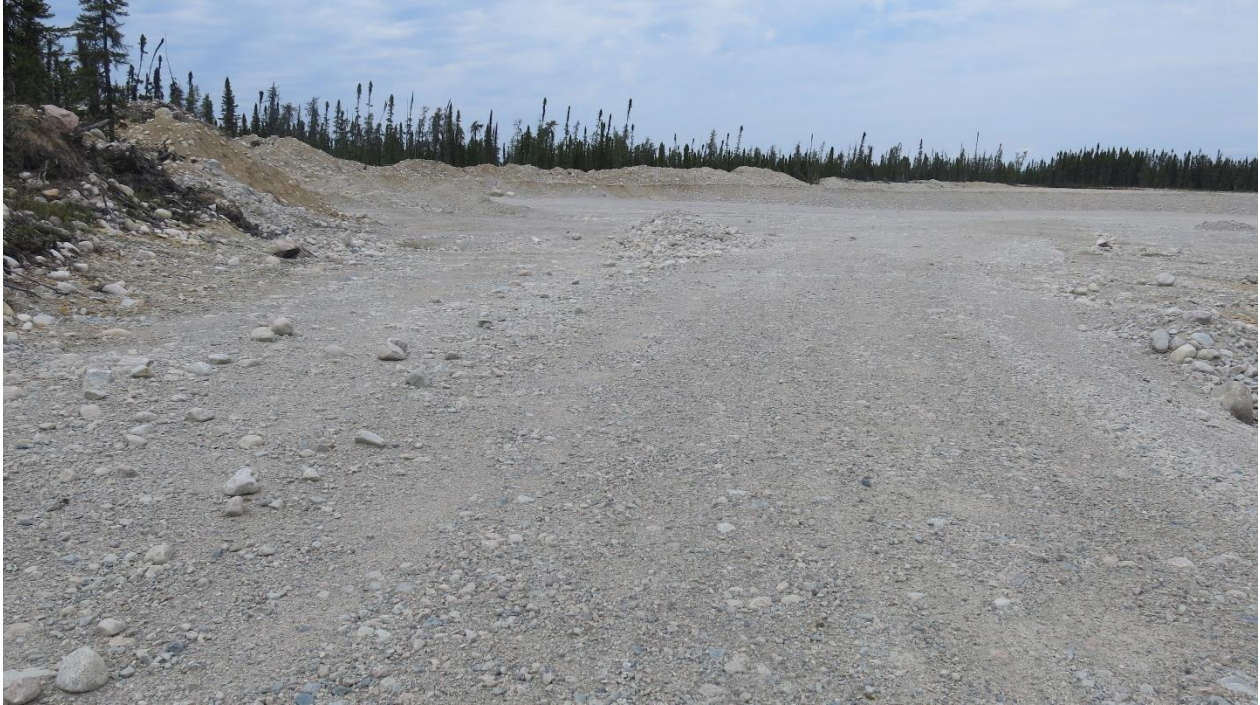
Photo 1 : Central portion of the GD-17 borrow pit.

The operation of the new portion (7 ha) of the GD-17 borrow pit will be conducted in the same manner as for the portion (3 ha) currently in operation (Photos 1 and 2). Materials will be mined either by direct loading, screening or crushing, depending on the specific needs of each project. There will therefore be no additional impact on the environment, except for the cutting of trees and stripping of the soil surface over an additional 7 ha. The volumes of material produced annually will be similar to what they have been in recent years and the methods of extraction and production of aggregates, as well as the mode of transportation of materials, will be identical. Therefore, there will be no increase in noise levels or in the amount of dust emitted into the environment.

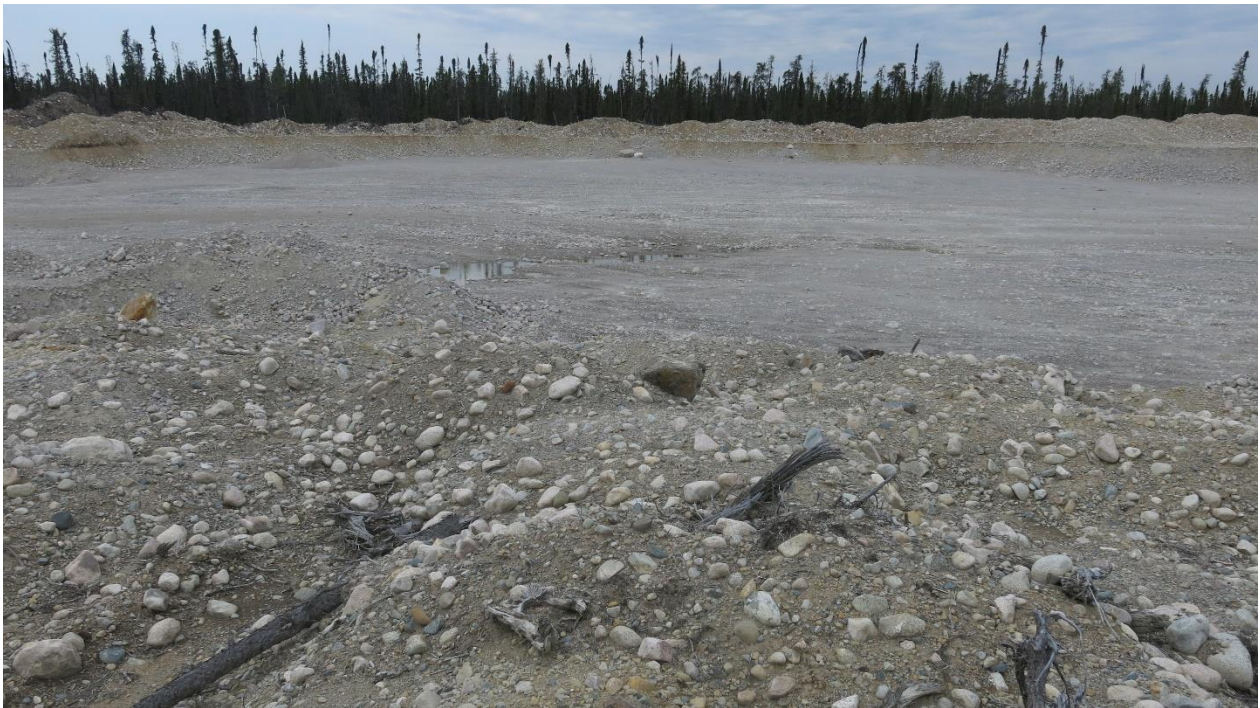
Photo 2 : Central portion of the GD-17 borrow pit.

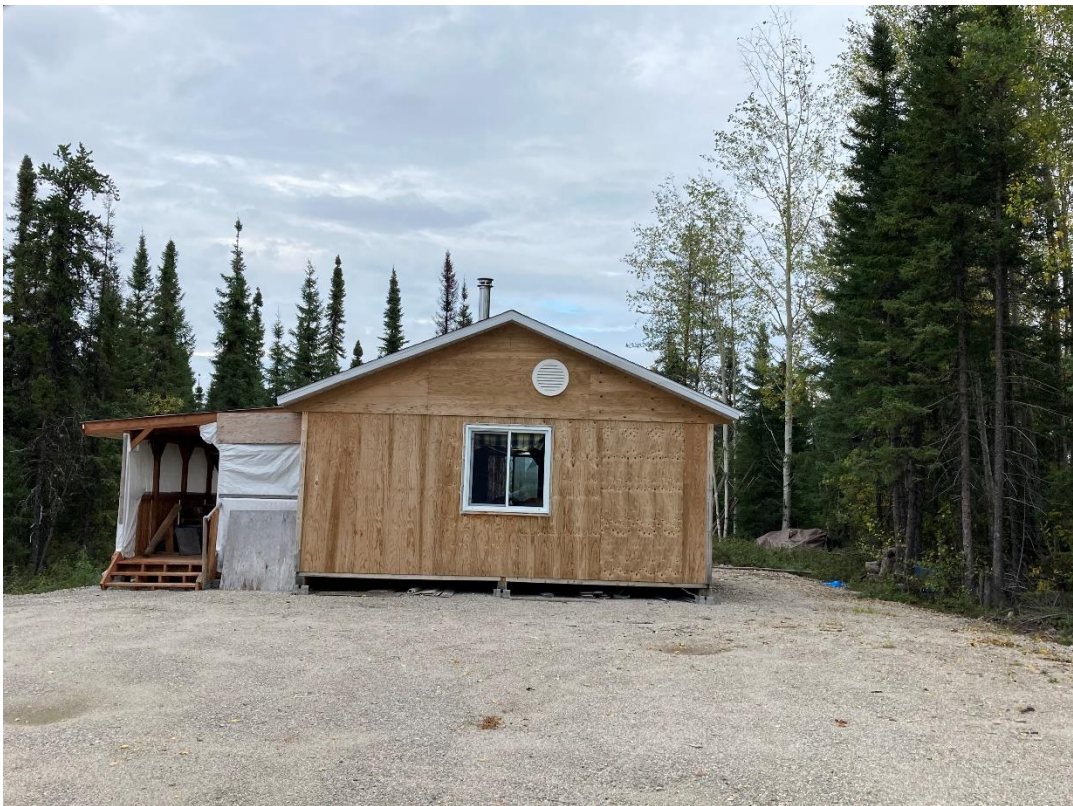
Photo 3 : View of 4 of the 5 cabins located on the west bank of the Pontax River, approximately 800 m south of the proposed boundary of the GD-17 expansion (see Map 1).

Five cabins (Photos 3 and 4) are located 800 m south of the closest part of the proposed borrow pit extension and two additional cabins (Photo 5) are located approximately 550 m from this boundary. Cabins users will not be able to see the development area from their cabins because a strip of forest of approximately 30 m wide will be maintained around the site and because the cabins themselves are surrounded by trees. Residents will not be bothered by noise or dust during the operation of the site because they are far enough away and the prevailing winds are from the west.

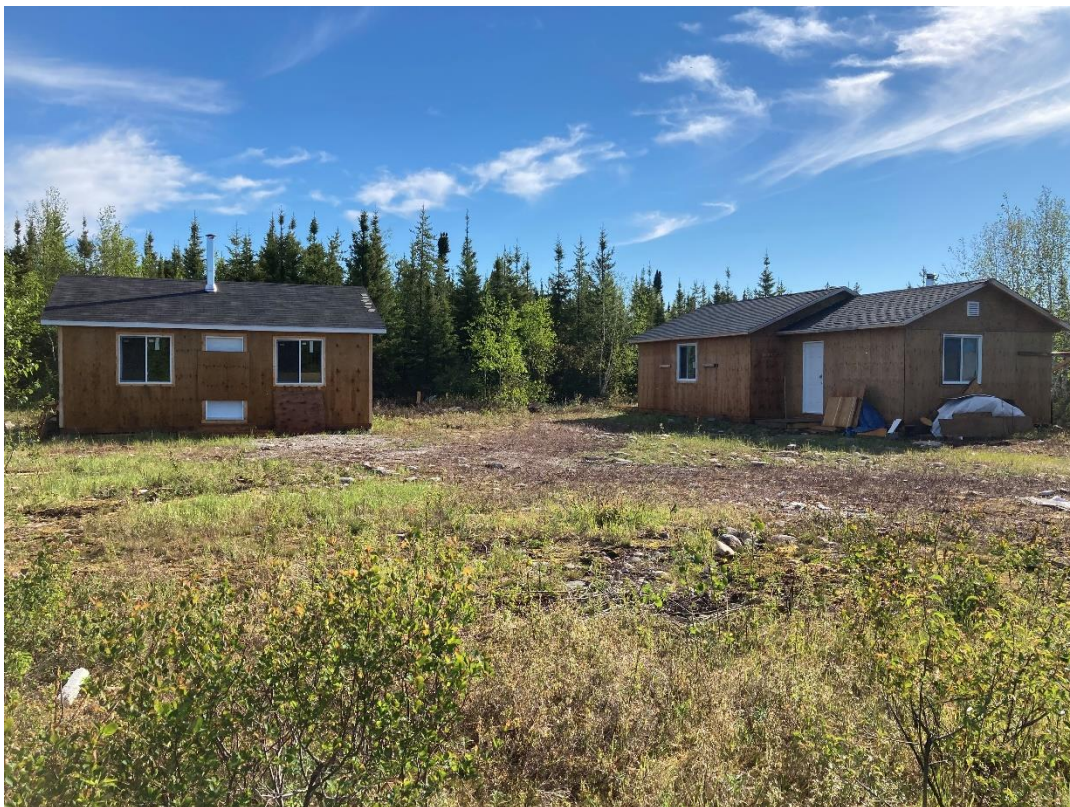
Photo 4 : View of the 5th cabin located on the west bank of the Pontax River, approximately 800 m south of the proposed GD-17 expansion boundary (see Map 1).

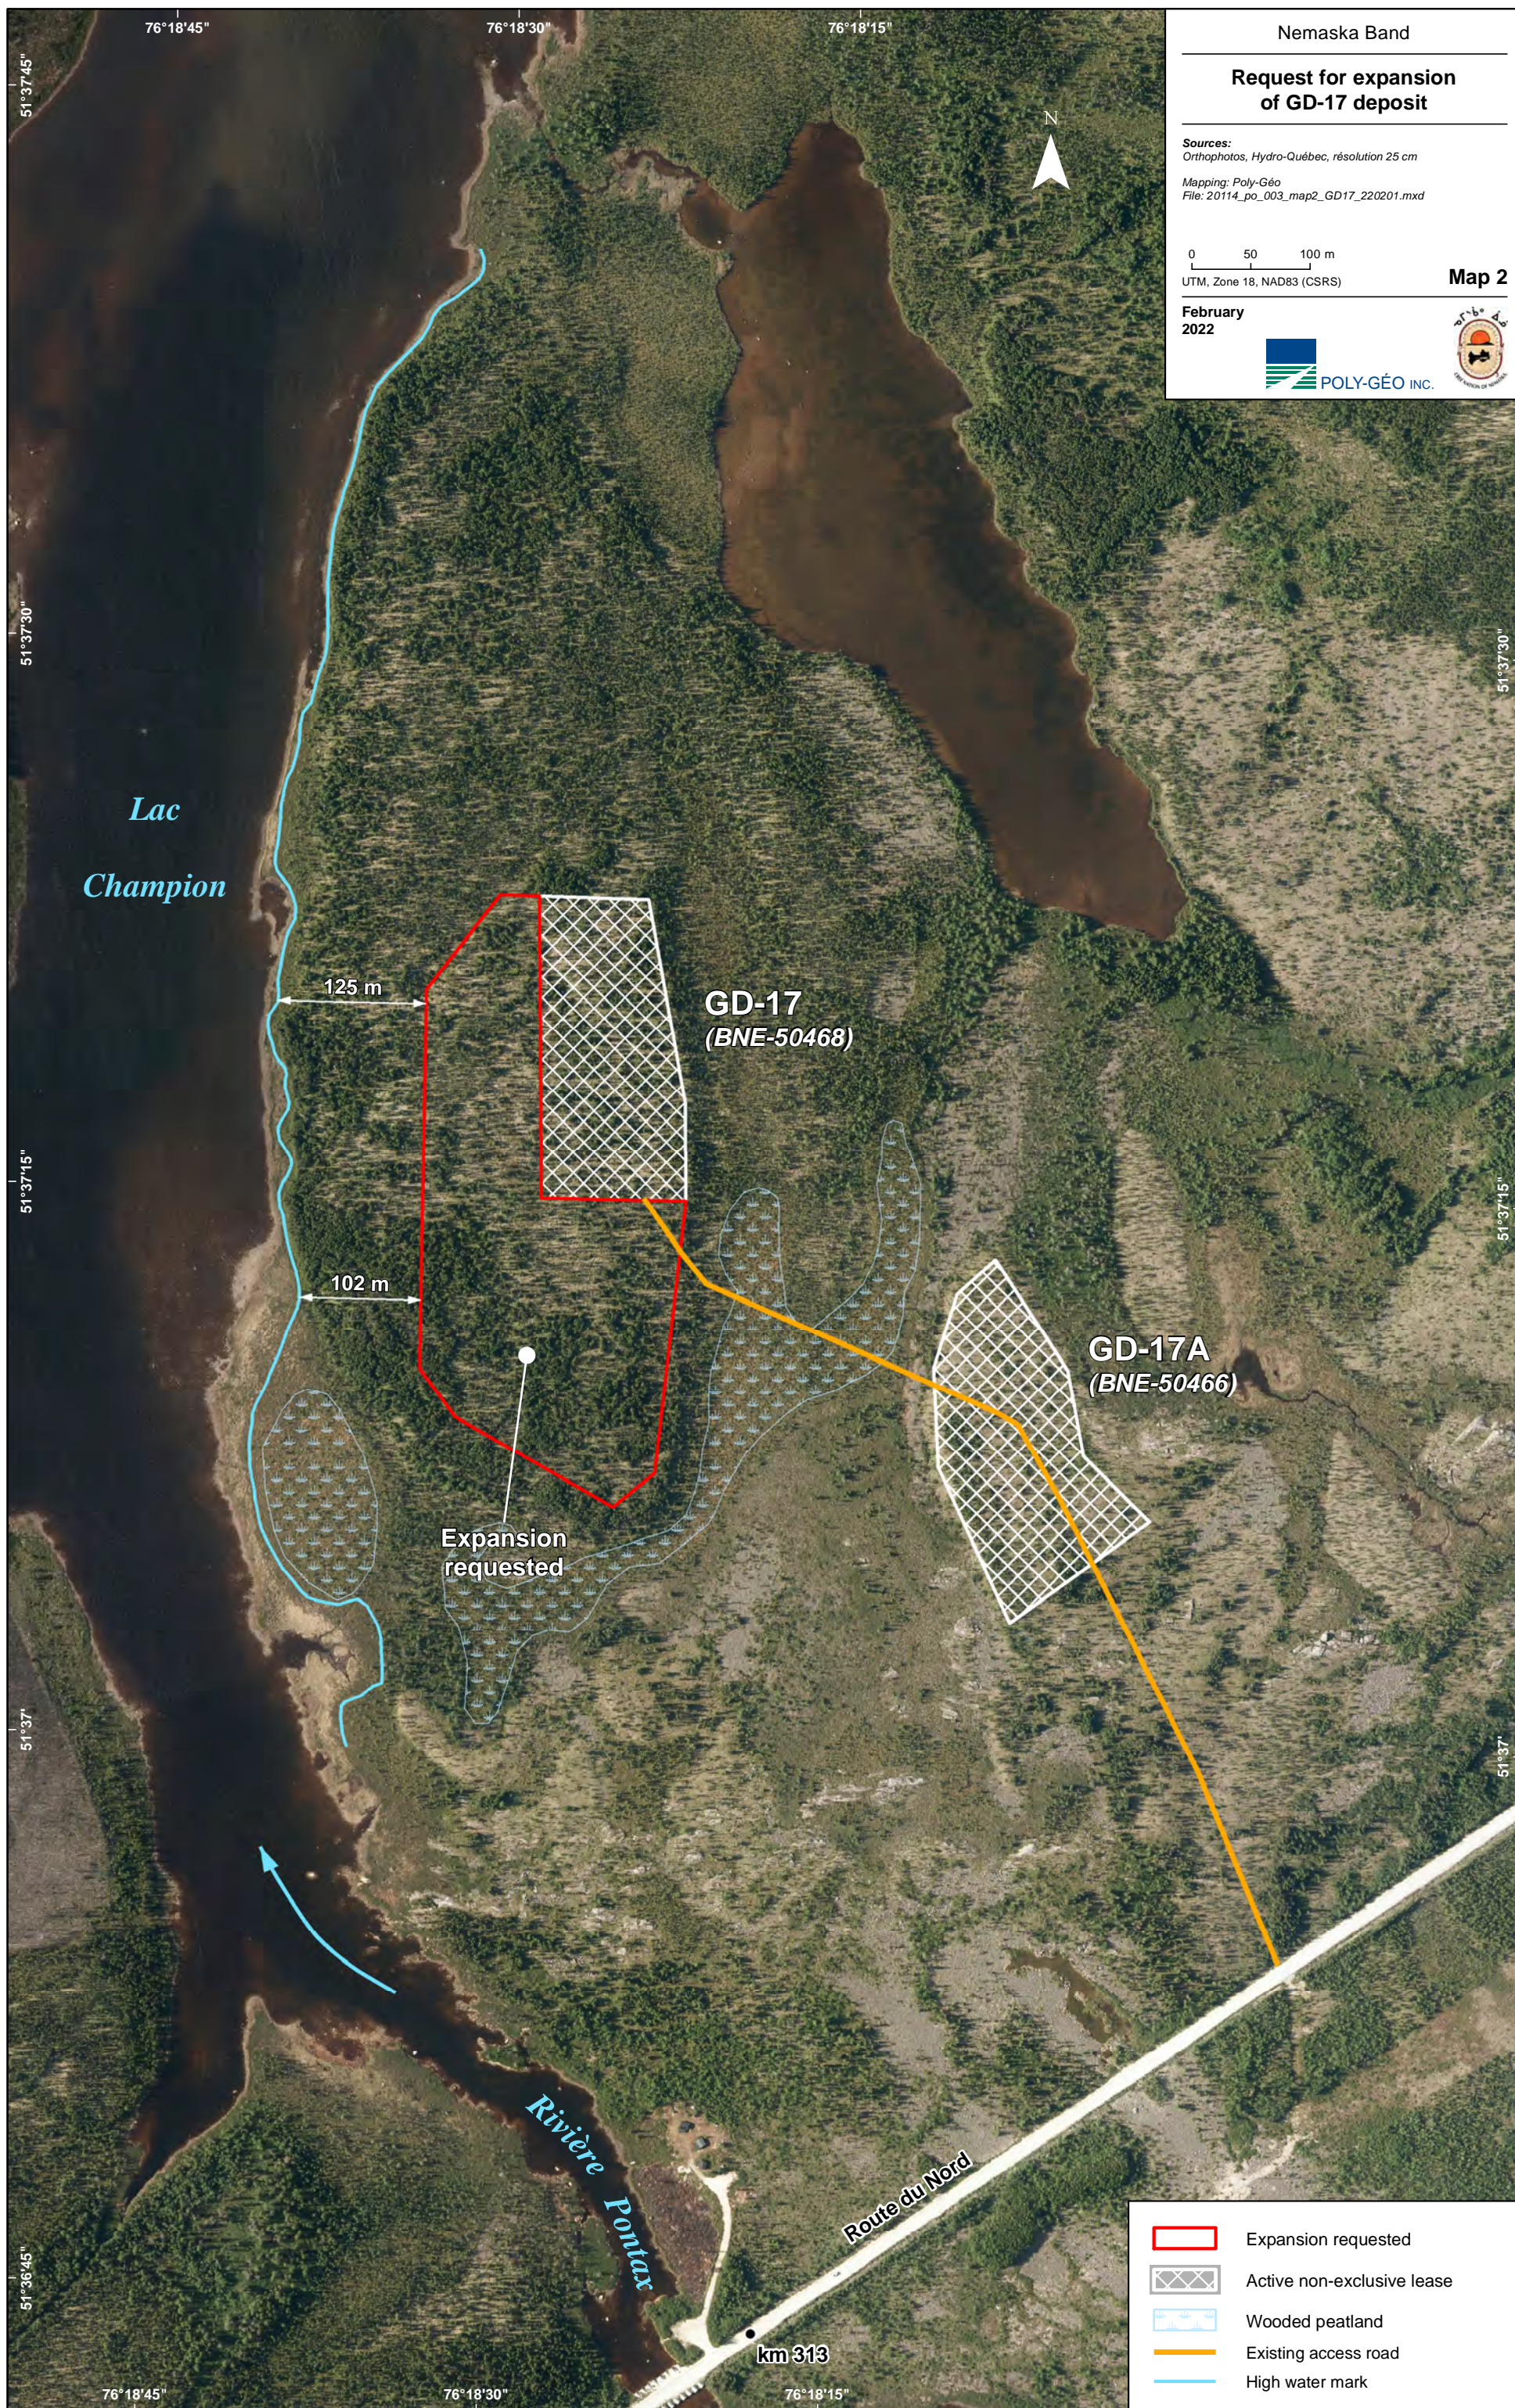
Map 2

MAP SHOWING THE PROPOSED
DEVELOPMENT AREA FOR GD-17
AND THE 100 M WIDE PROTECTION
STRIP TO BE MAINTAINED BETWEEN
THE HIGH WATER MARK OF
CHAMPION LAKE AND THE
DEVELOPMENT AREA

Request for expansion of GD-17 deposit

In order to meet the requirements of Section 122 of the *Règlement sur l'aménagement durable des forêts* (RADF), a 100 m wide protection strip between the high water mark (HWM) of Champion Lake and the limits of the borrow pit will be respected to ensure the protection of lake sturgeon and its habitats. This protection strip was already applied in the document initially submitted for the non-subjection request (Map 2 of Appendix 2 of the Preliminary Information Form submitted on May 3, 2021 to COMEV). To be safe, this strip will be measured on foot, directly in the field, using a hip chain and delineated by close, visible and distinctive marking of trees around the perimeter of the area being logged. Personnel will be notified of these boundaries and required to respect them or face penalties.

The map in Appendix 3 shows that a minimum width of 100 m will be maintained between the limits of the GD-17 borrow pit and the high water mark (HWM).

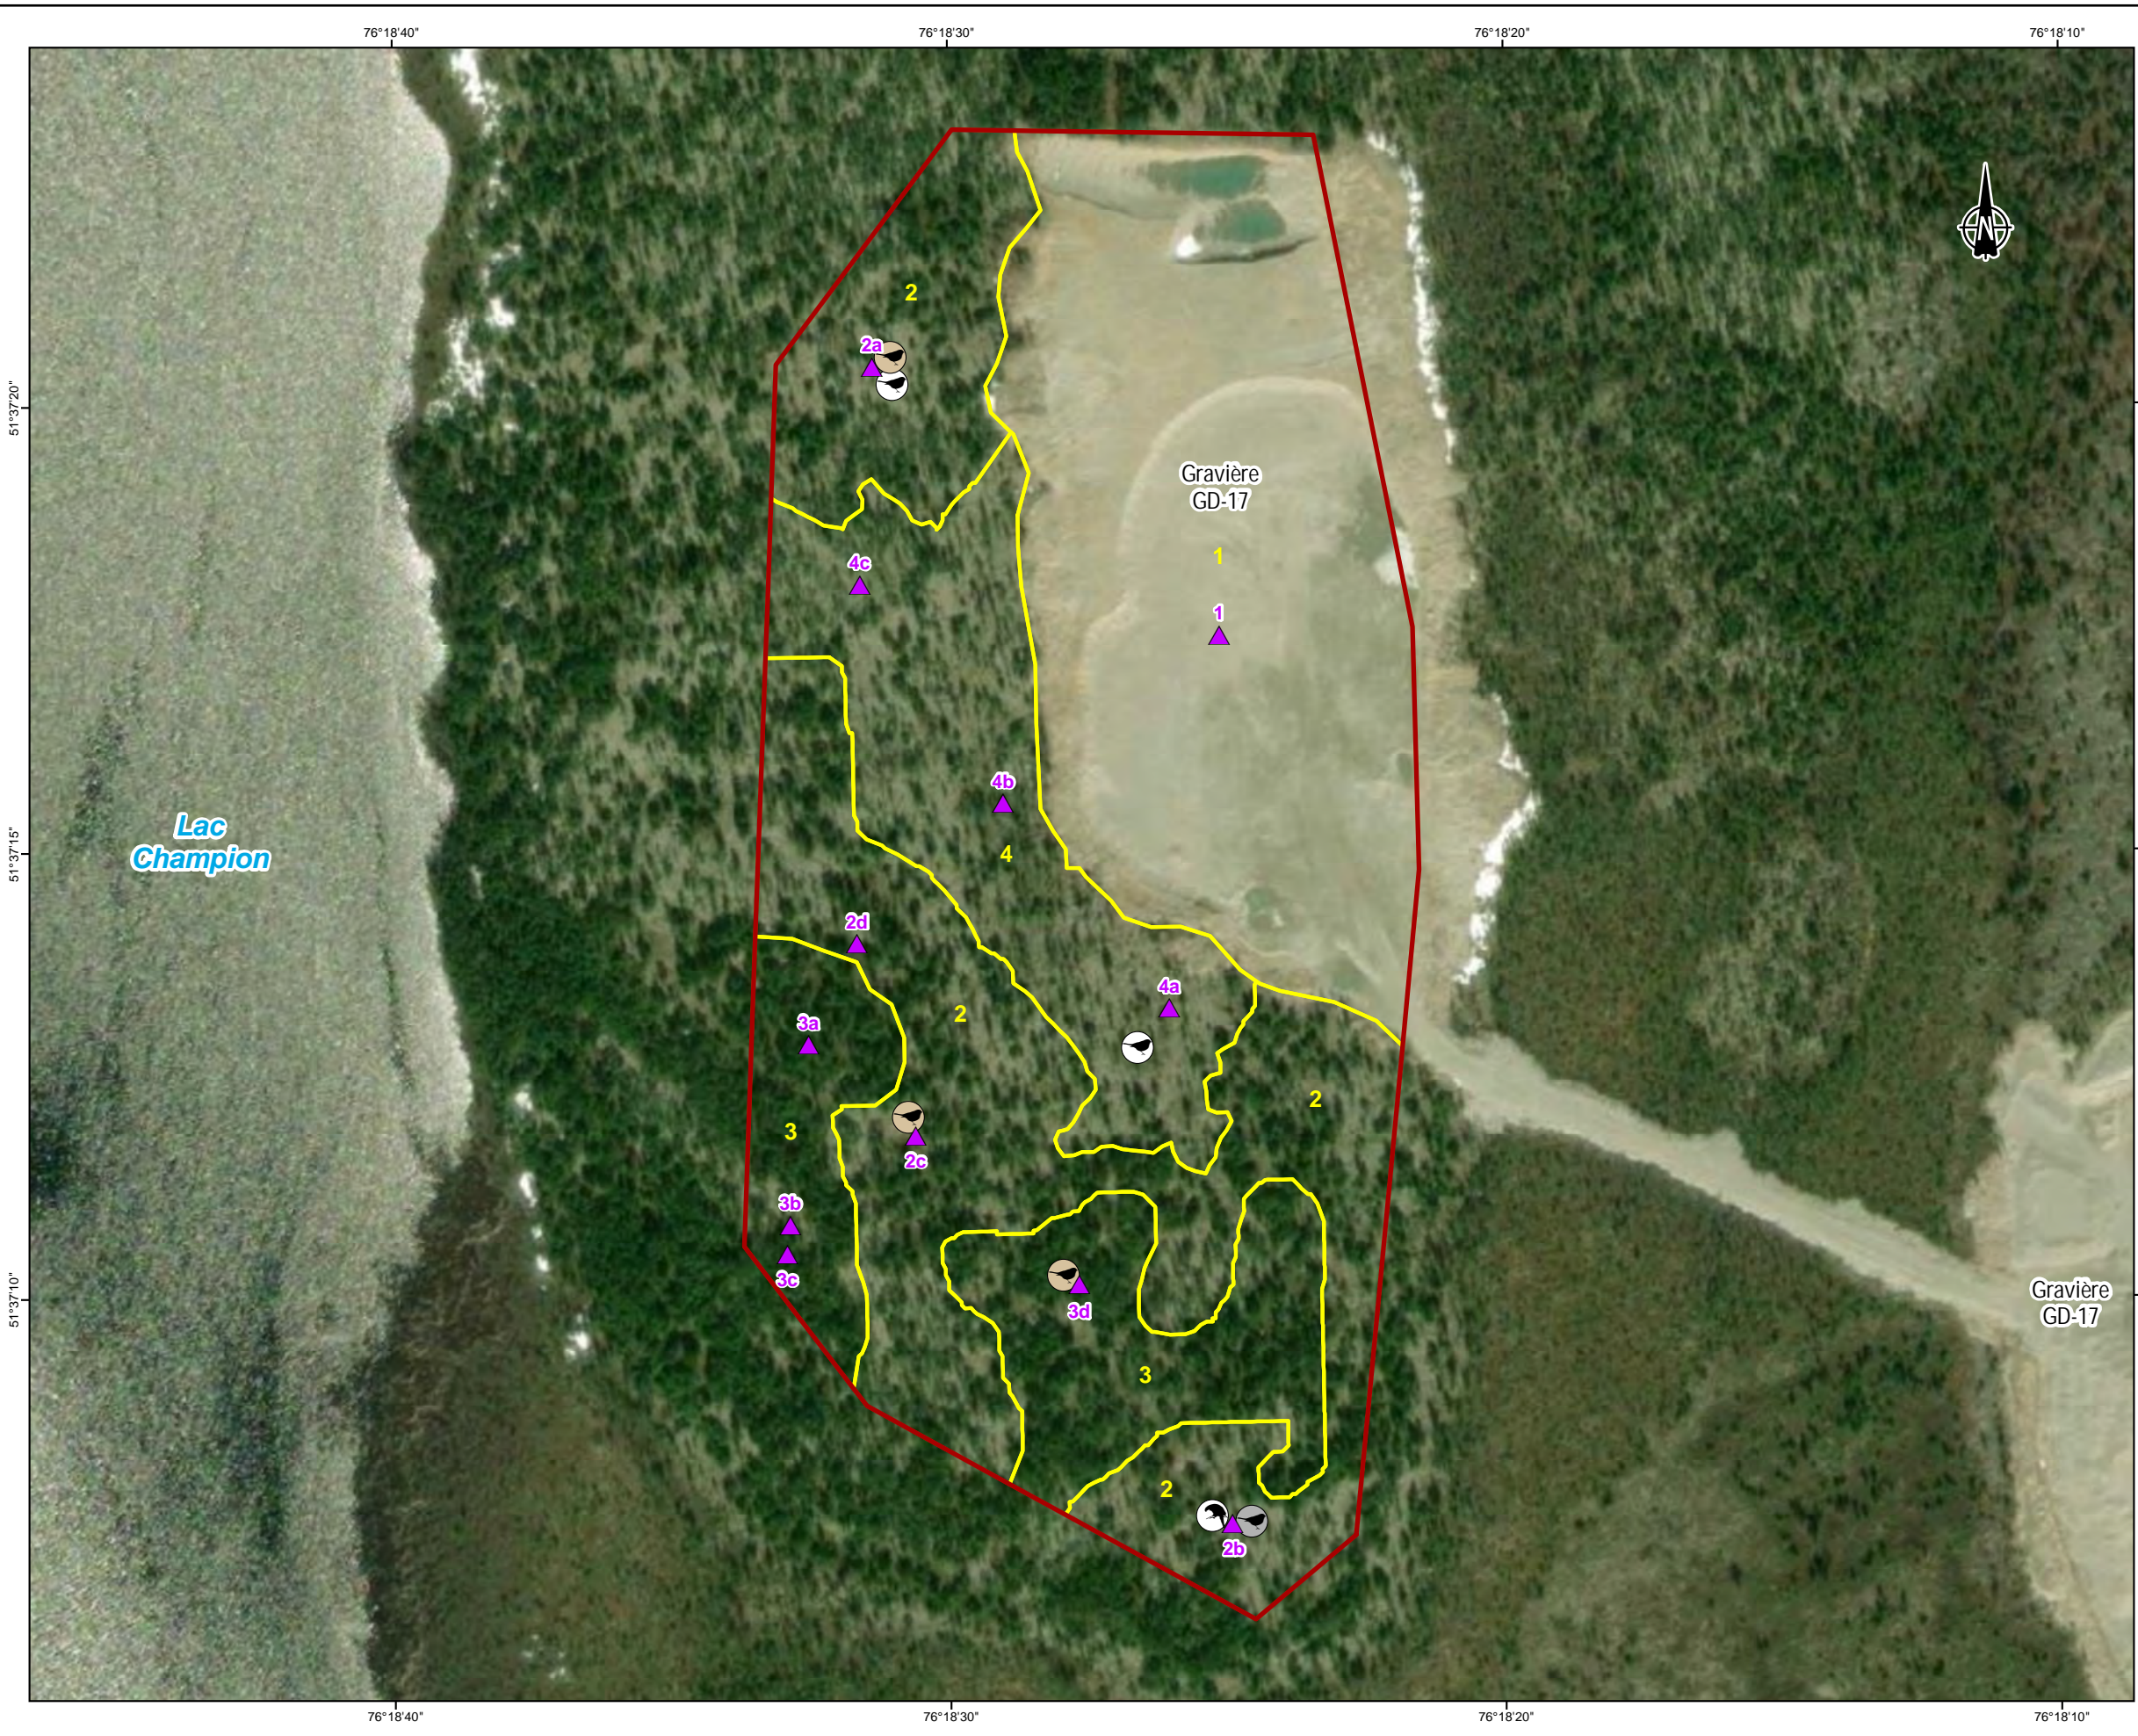
Photo-interpretation and ecological characterization during the field inventory resulted in the delineation of four EUs (Map 2). Table 1 refers to the different EUs presented in Map 2 and shows their occupied area and their main ecological characteristics. A photographic directory presenting each SU is included in Appendix 1.

Overall, the study area is divided into two main components: an anthropogenic environment corresponding to the gravel pit in operation as well as spruce stands of different densities and whose undergrowth is dominated by various species. The different environments are not considered wet because of the affinity of boreal plants proposed by Jean Deshayes. The appendix lists the 18 plant species identified during the field survey.

The fourth ecological unit is a narrow-leaved kalmia and cladonia heath (*Cladonia* sp.; Stations 2, 4a, 4b, 4c on Map 2, photos 8-11 in Appendix 1). This 1.56 ha unit is located in the center of the study area and is adjacent to the active gravel pit. The area is located on a flat, irregular terrain with no depression. The soil is 15 cm deep and includes a 14 cm mesic organic horizon. A thin layer of coarse sand covering the loose, coarse-textured material completes the soil horizons. Mature vegetation is codominantly black spruce and jack pine with an absolute cover of 8% and 5% respectively. The low tree density (<10%) qualifies the unit as a heathland. The shrub layer is 83% narrowleaf kalmia, accompanied by other shrub species including black spruce, Labrador tea, and blueberry (*Vaccinium myrtilloides*). Waterlogged bryophytes and lichens cover most of the ground.

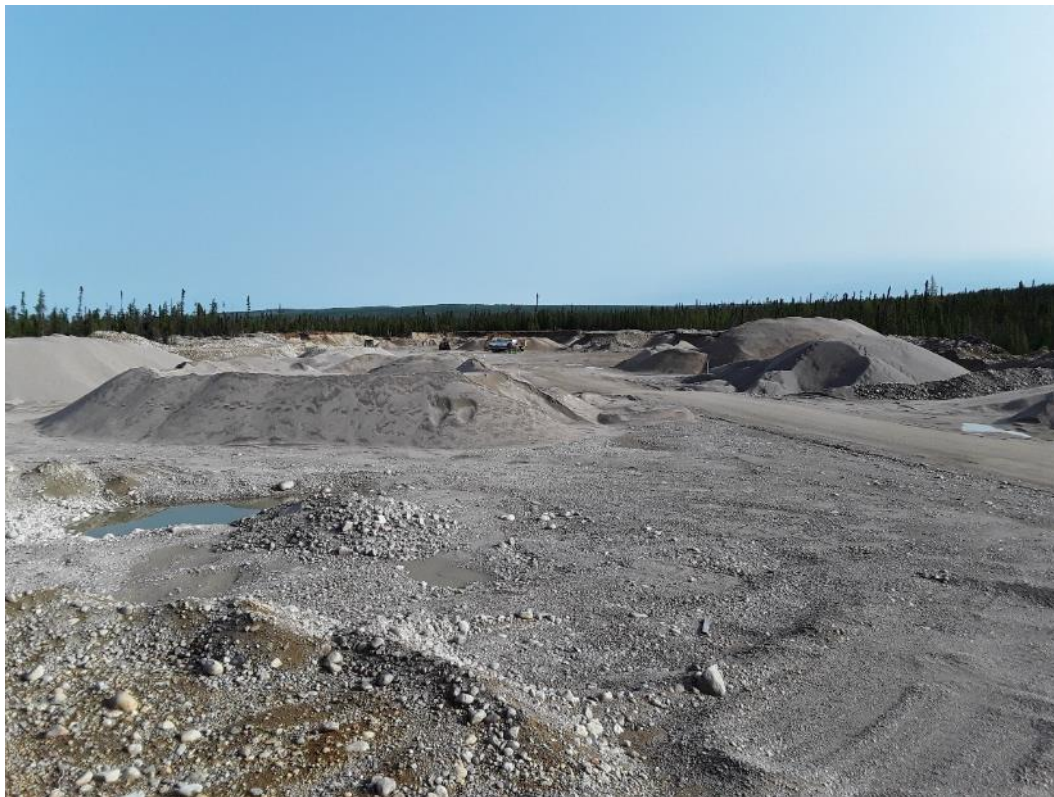
Photo 1 Gravière GD-17 en exploitation (UE1)

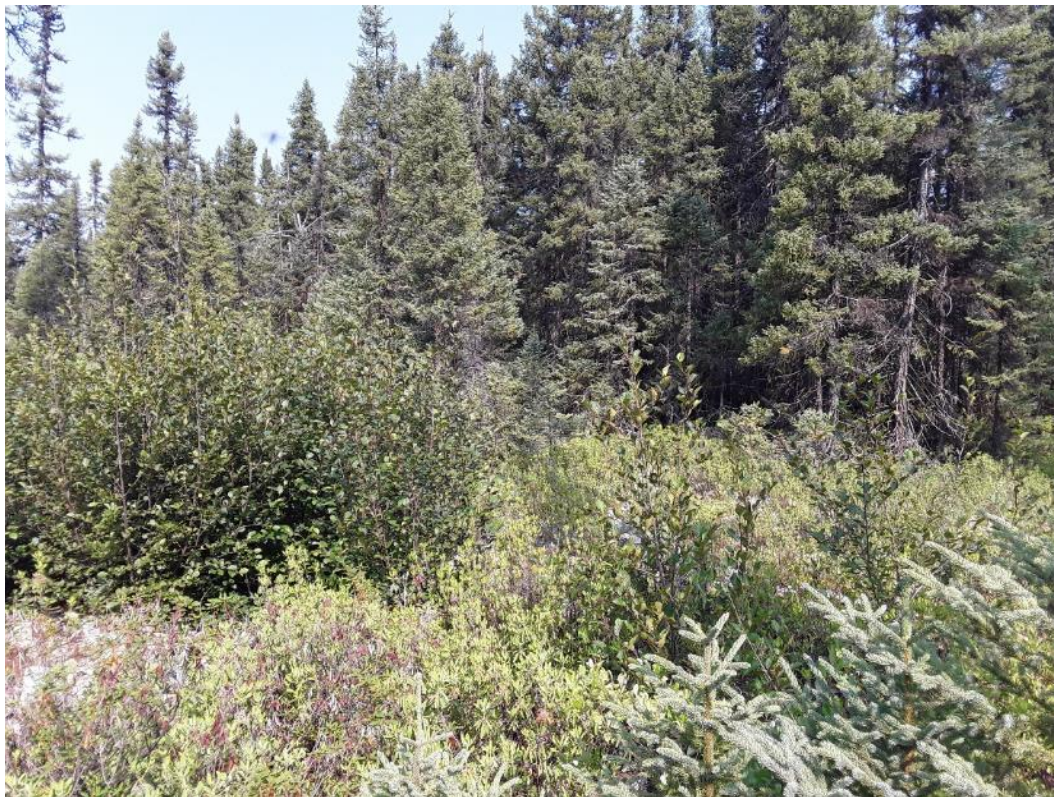
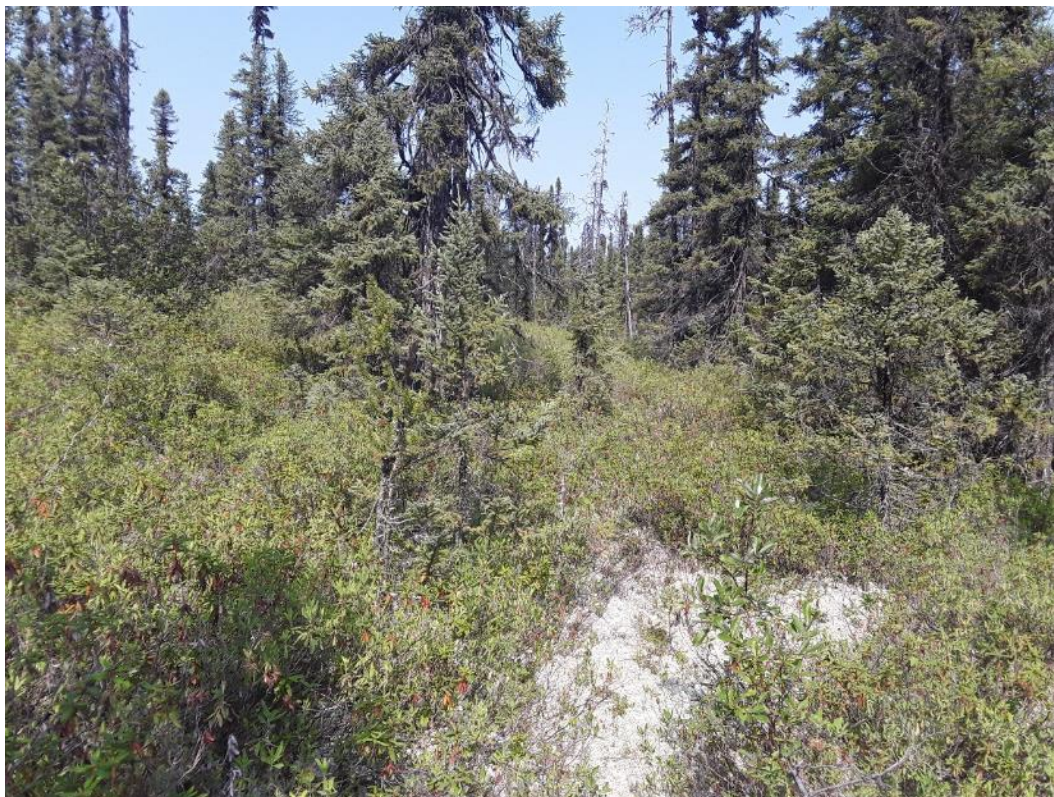
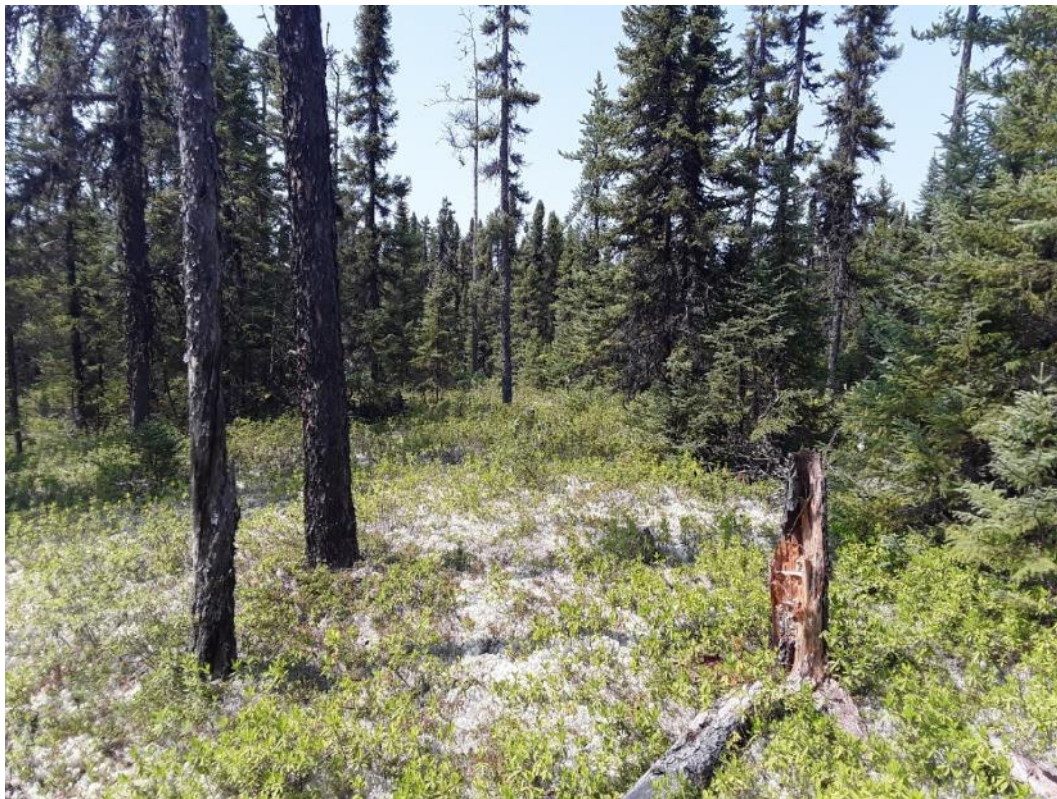
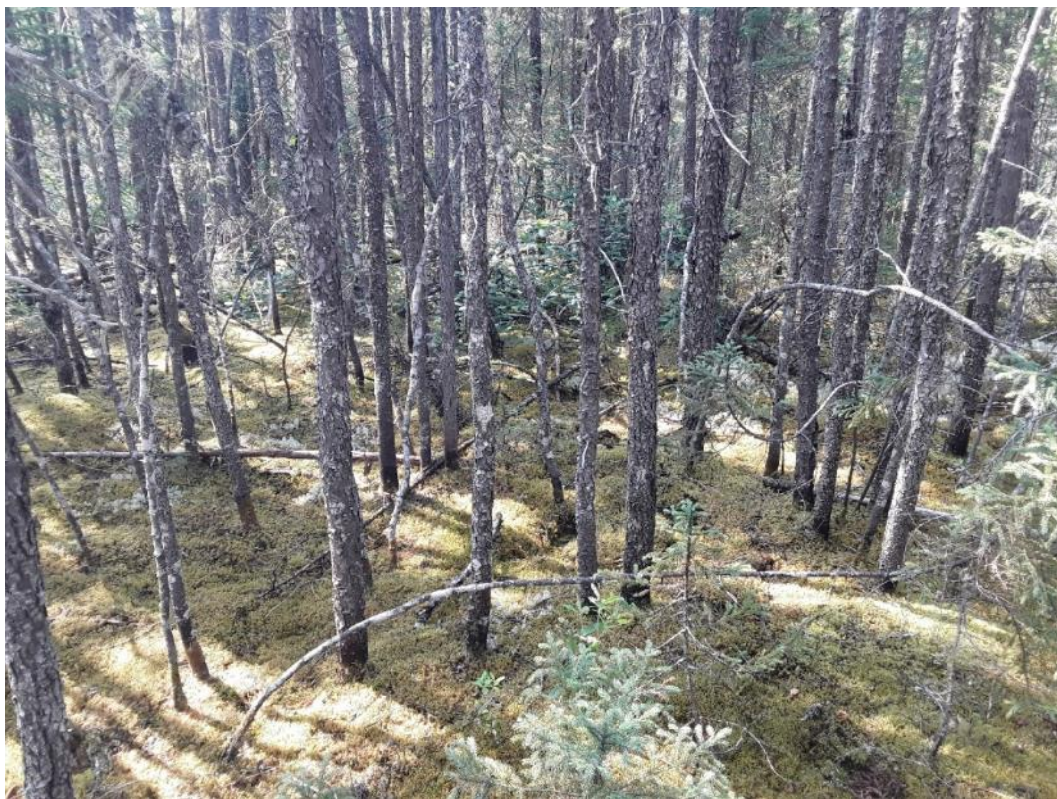
Photo 2 Ouverture forestière dans la pessière à pin gris et kalmia à feuilles étroites (UE2)

Photo 3 Portion arbustive de la pessière à pin gris et kalmia à feuilles étroites (UE2)

Photo 4 Milieu terrestre de la pessière à pin gris et kalmia à feuilles étroites (UE2)

Photo 5 Milieu terrestre de la pessière à pin gris et kalmia à feuilles étroites (UE2)

This environment is present at two locations in the study area and four identification stations allowed its characterization (Map 2; photos 2 to 5 in Appendix 1). The first sector (station 2a), with a size of 0.799ha, is located in the upper northwest corner. It shares a portion of its boundary with the gravel pit in operation (UE1). The second portion (stations 3a, 3b, 3c) of this EU, measuring 2.569ha, is located further south, below EU4, and intersects the study area from west to east. Its total area corresponds to more than a third of the study site (34%). The sampling points of these units show a humus layer about 8 cm thick covering an A horizon composed of coarse sand over about ten centimeters. The B horizon is characterized by the presence of loose, coarse-textured material at a depth of 18 cm. The two portions of EU2 are located on a gentle slope and

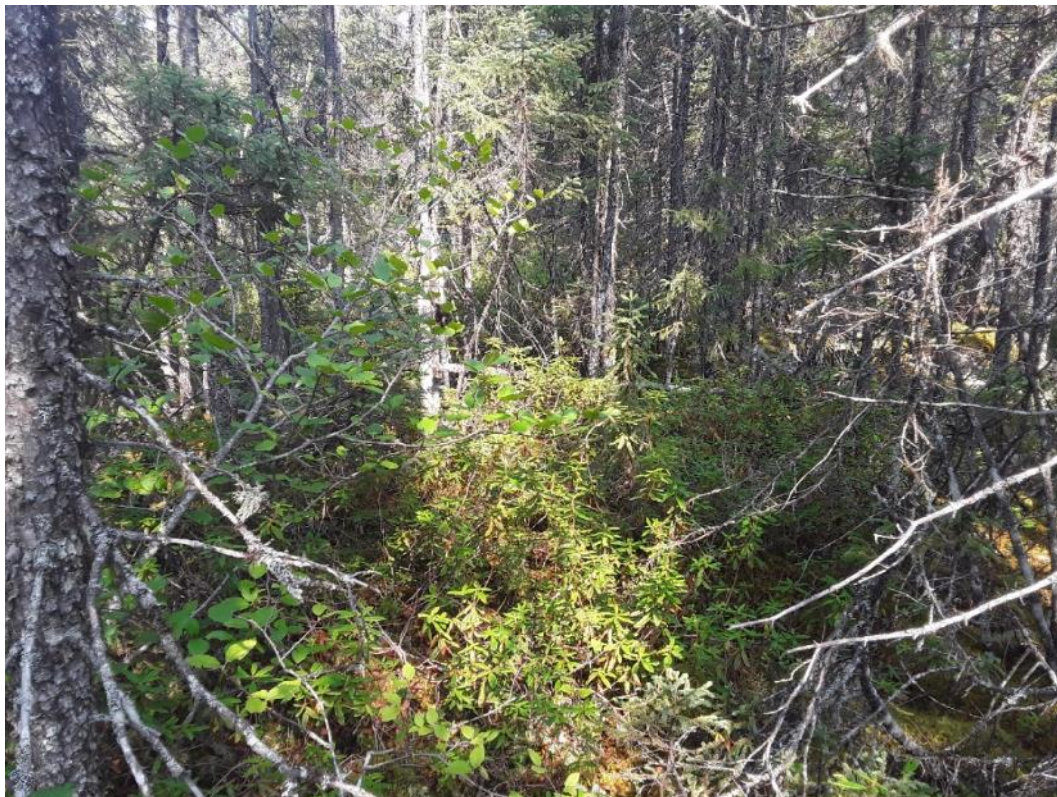
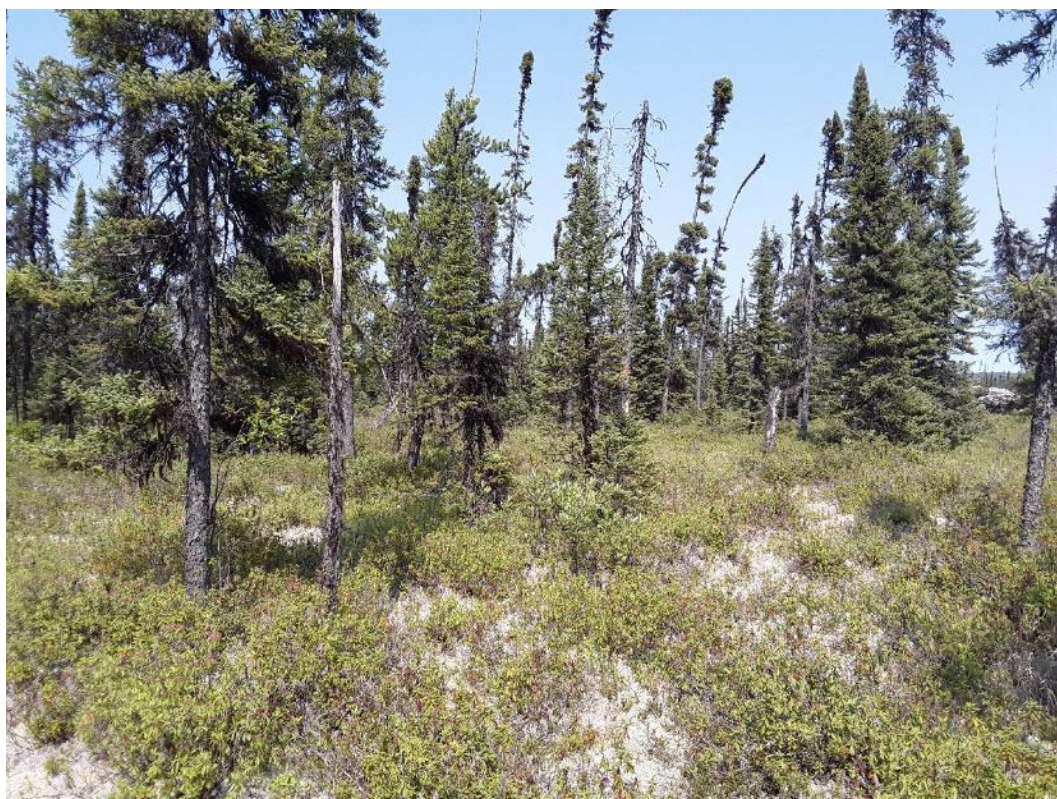
Photo 6 Sous-bois de la pessière à thé du Labrador (UE3)

Photo 7 Sous-bois de la pessière à thé du Labrador (UE3)

The Labrador tea spruce forest is intersected longitudinally by the EU2, separating it into two areas (stations 2, 4a, 4b, 4c on map 2; photos 6 and 7 Appendix 1). The total area of these sectors covers less than 20% of the study area. These areas are located on gentle upper slopes, on irregular terrain, and have rapid drainage. The soil is similar to that of EU2. The A horizon is composed of coarse sand over about ten centimeters and granular materials characterize the B horizon. The tree layer is completely dominated by black spruce with a cover of 30%. This species is also present in the shrub layer (48%) and dominates this layer with Labrador tea (26%). Narrow-leaved kalmia, narrow-leaved blueberry and an unidentified northern species of birch (*Betula* sp.) are also present in smaller proportions.

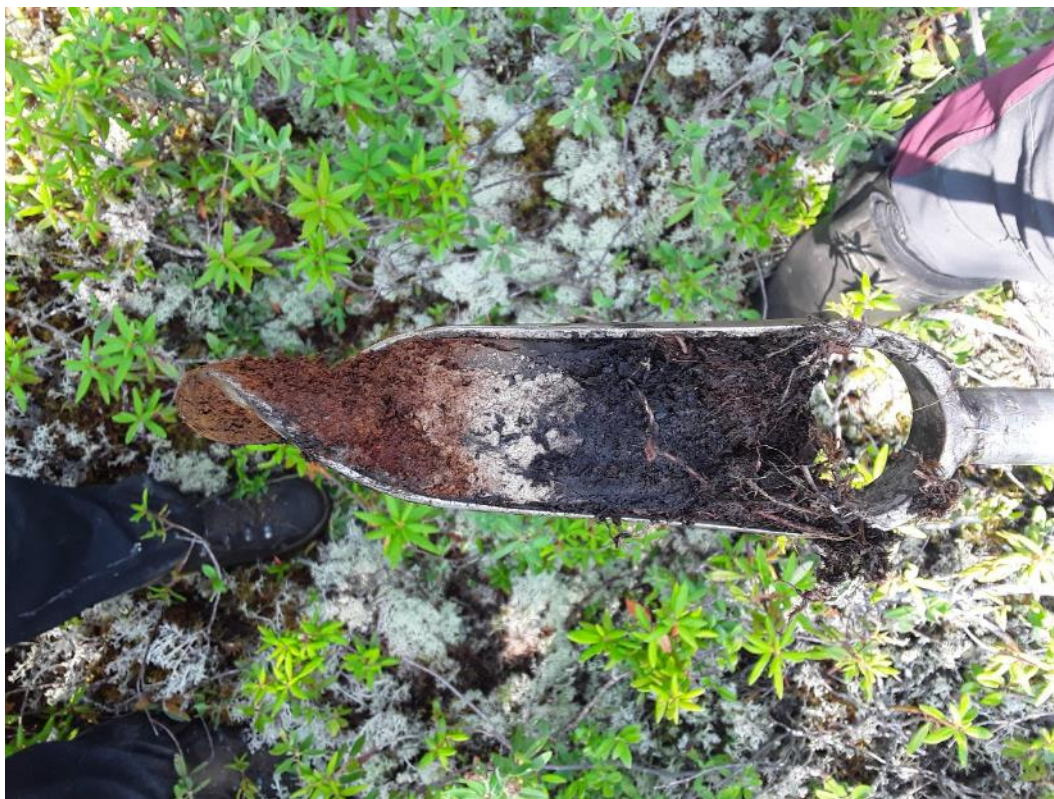
Photo 11 Échantillon de sol de la pessière à kalmia à feuilles étroites et cladonie (UE4)
