**RESURFACING AND PAVING
OF THE WEMINDJI ACCESS
ROAD-
WEMINDJI (QUÉBEC)**

Environmental Project Notice

157710050-202-105-EN-R0003-00

March 2, 2017

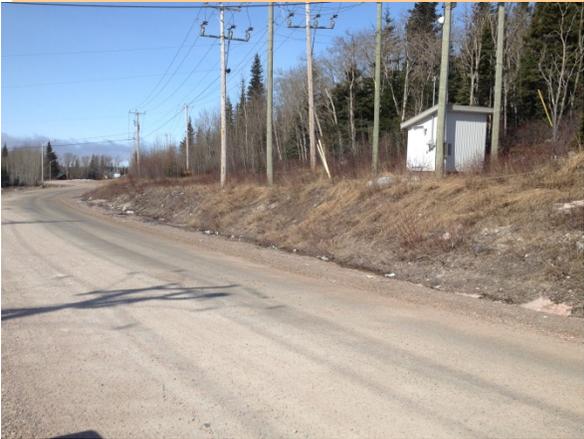
Photo 60: following the ditching required at this location and placement of the aggregate overlay in the sector after the culvert is installed at station 1+000, an entrance with an HDPE 600 culvert is needed to access the electrical shed.

Photo 60: 1+200 Culvert required if rock is excavated from the ditch

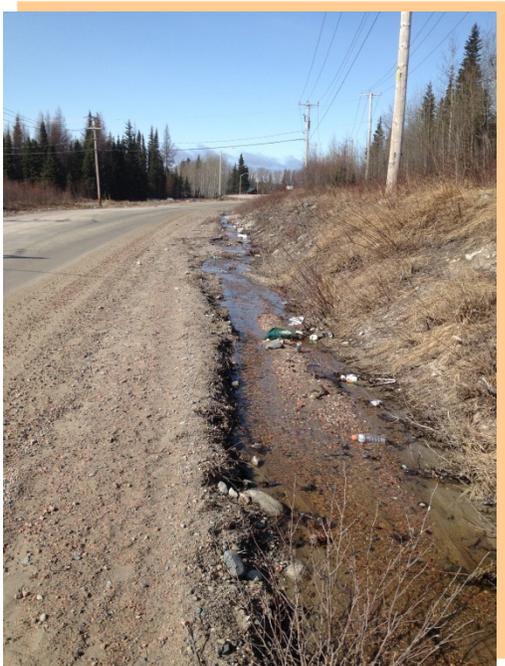
In a number of locations, we noted obvious drainage problems, either there were no ditches at all or, for example, the granular materials in the berms prevented water from flowing away from the roadbed.

Photo 58: 1+100 to 1+200 L MIN ditch – facing west

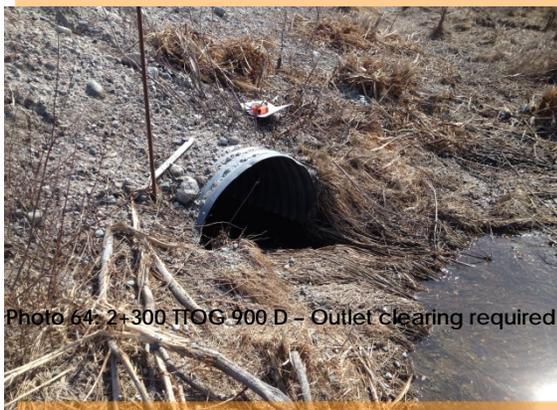
Photo 64: 2+300 TTOG 900 D – Outlet clearing required

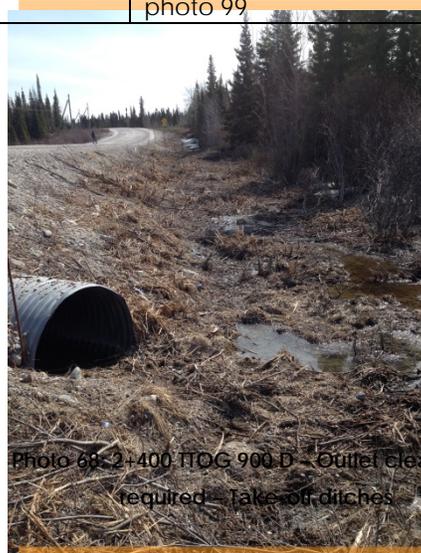
Photo 68: 2+400 TTOG 900 D – Outlet clearing required – Take-off ditches

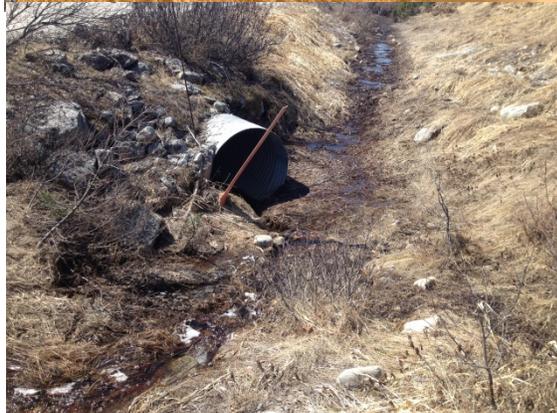
Photo 92: 13+800 TTOG 1200 – Inlet clearing required

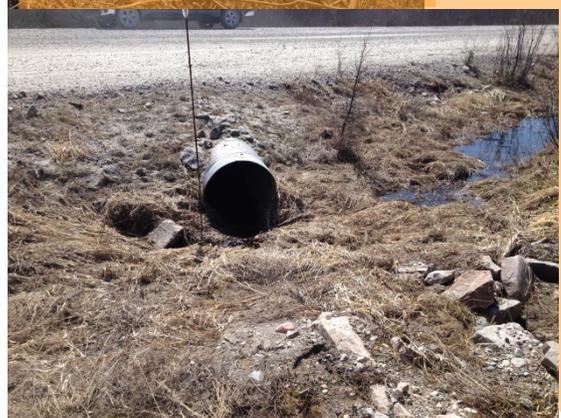
Photo 99: 15+400 TTOG 900 – Inlet clearing required

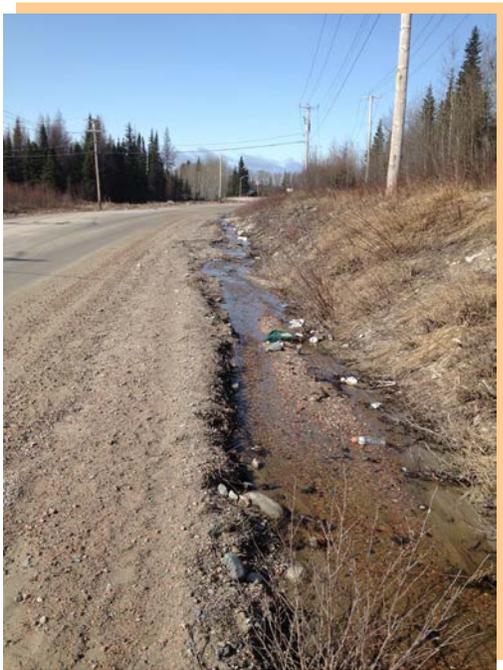
Photo 58: 1+100 to 1+200 L MIN ditch – facing west

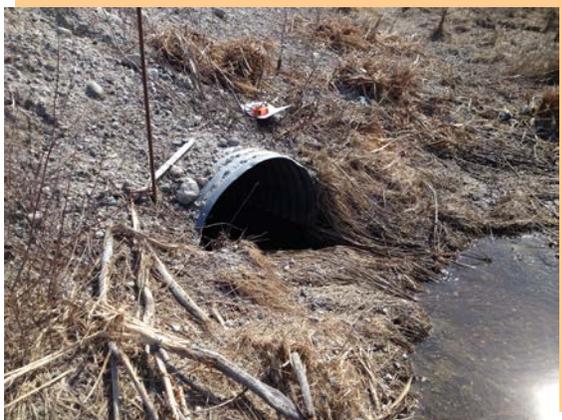
Photo 64: 2+300 TTOG 900 D – Outlet clearing required

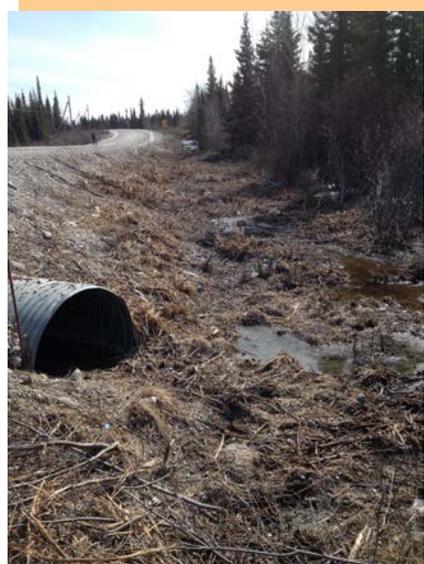
Photo 68: 2+400 TTOG 900 D – Outlet clearing required – Take-off ditches

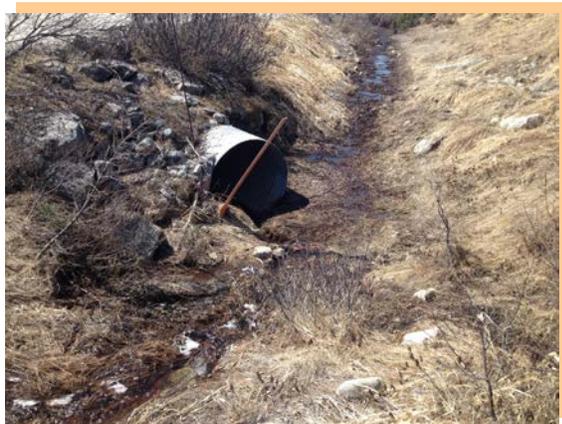
Photo 92: 13+800 TTOG 1200 – Inlet clearing required

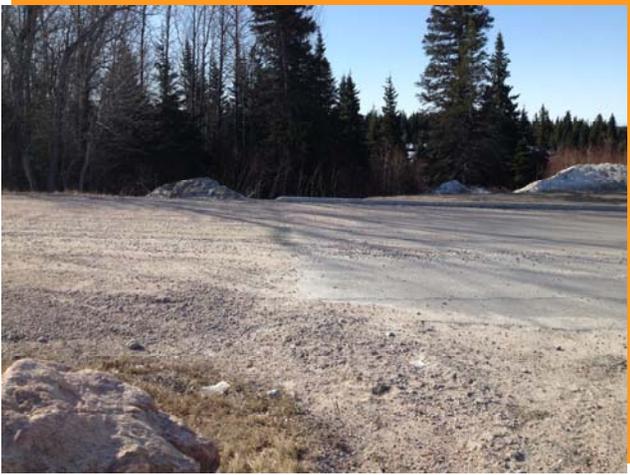
Photo 51: 0+800 – Connection to existing pavement, right

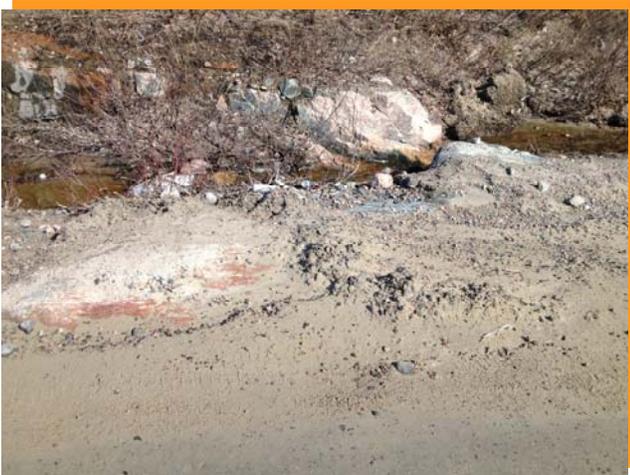
Photo 59: 1+200 – Rock in ditch and road surface

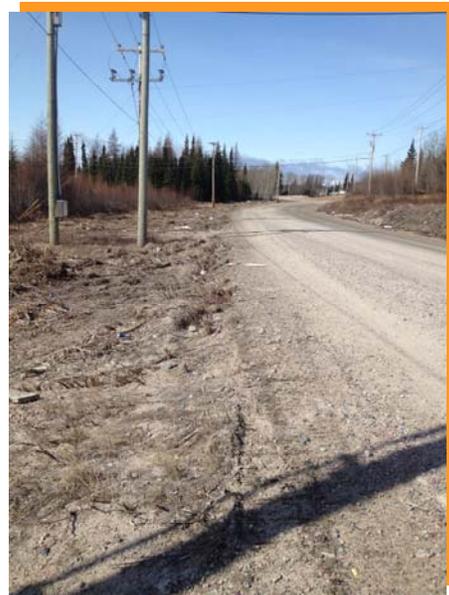
Photo 61: Ditch cleaning, right

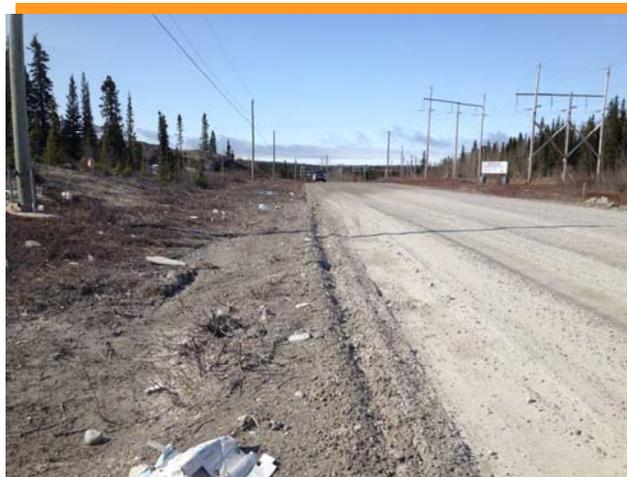
Photo 62: 1+300 – No ditch, west

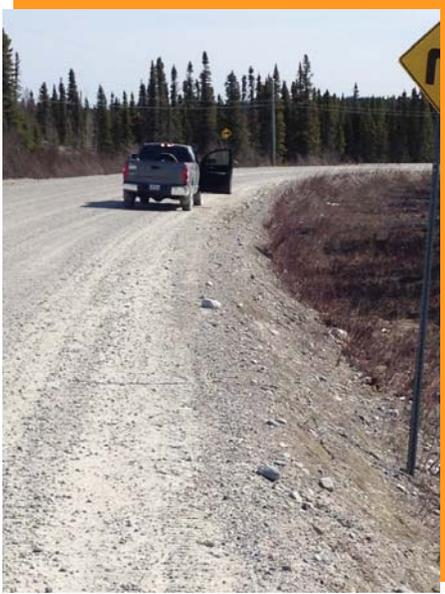
Photo 63: 2+005 à 2+140 – Washouts potential of talus if paving

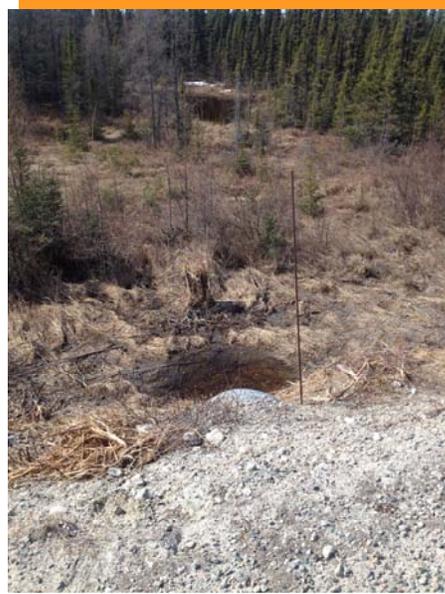
Photo 65: 2+300 – TTOG 900 – Culvert to be clean, right

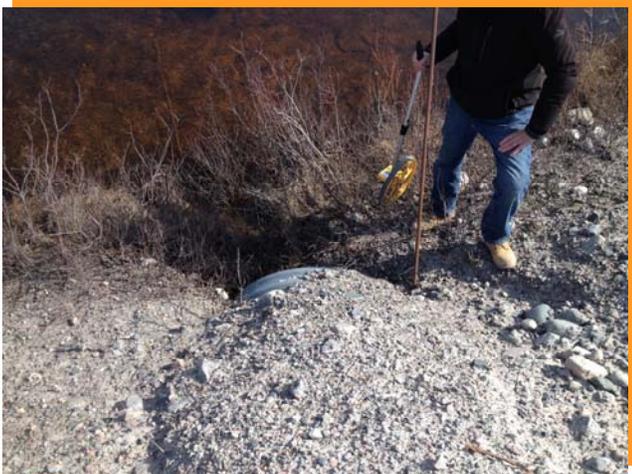
Photo 66: 2+300 – TTOG 900 – Entrance to be clean, left 1

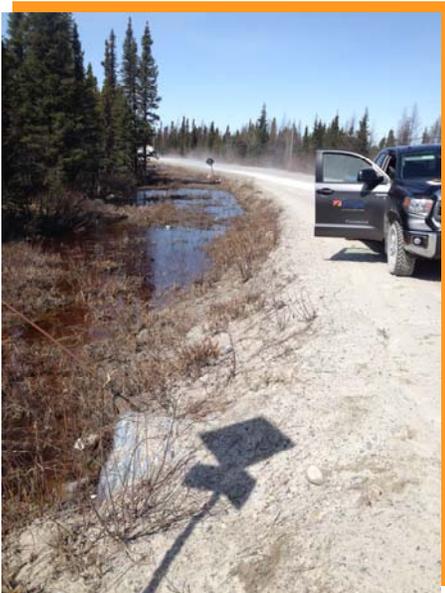
Photo 69: 2+900 – Water accumulation, west

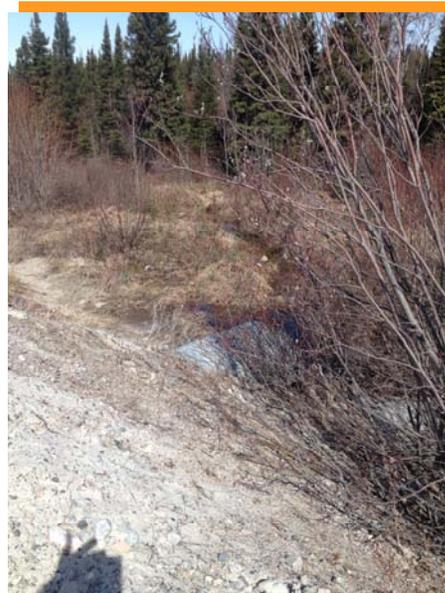
Photo 70: 2+900 Water accumulation, west

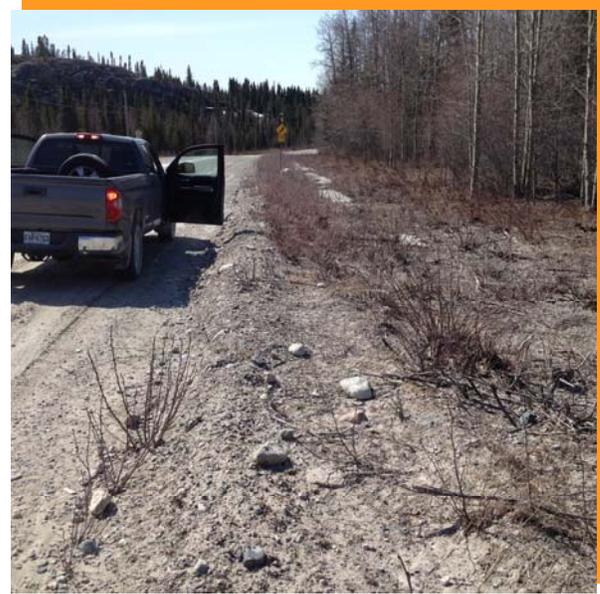
Photo 76: 3+700 à 4+100 - MG-20 berms

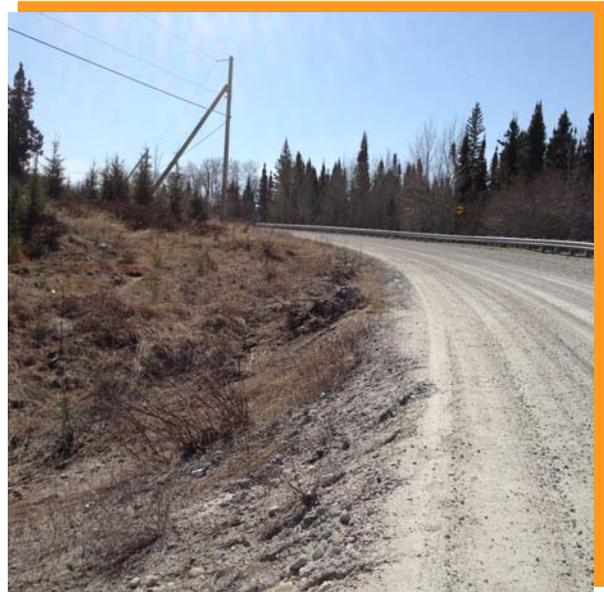
Photo 82: End ditch reprofiling, east

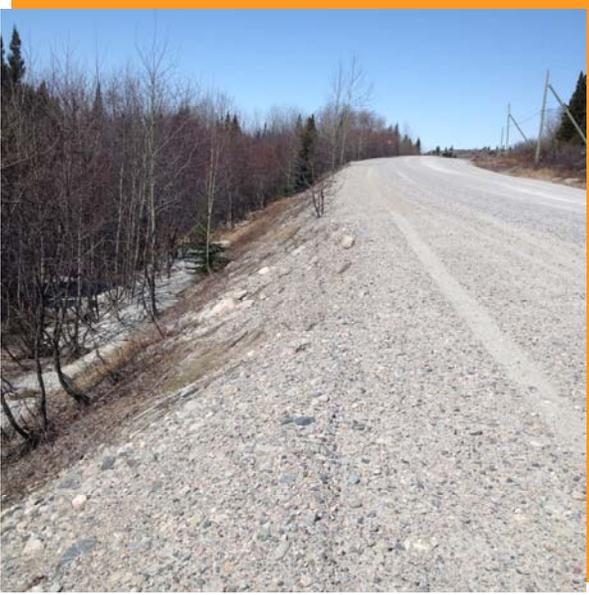
Photo 83: 4+500 – Long slope

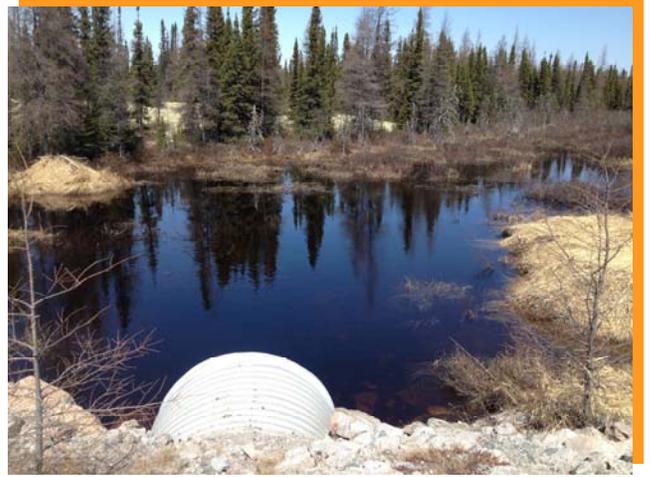
Photo 85: 7+800 – Possibility of fish presence

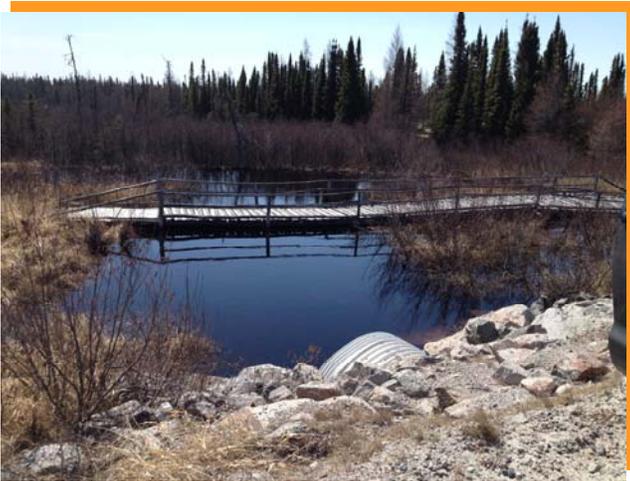
Photo 86: 7+800 – Possibility of fish presence

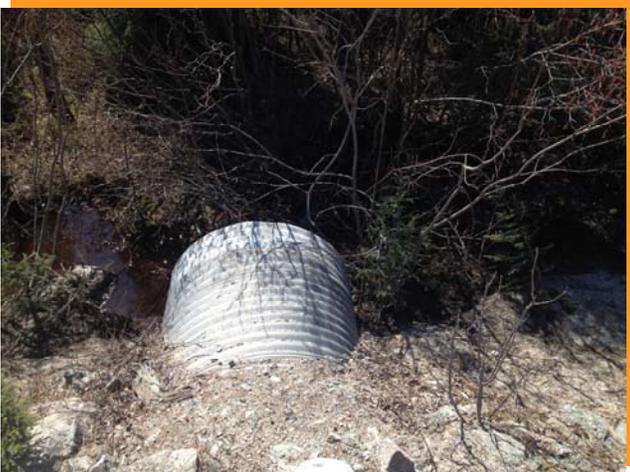
Photo 88: 11+750 – TTOG 1200 – Low flow

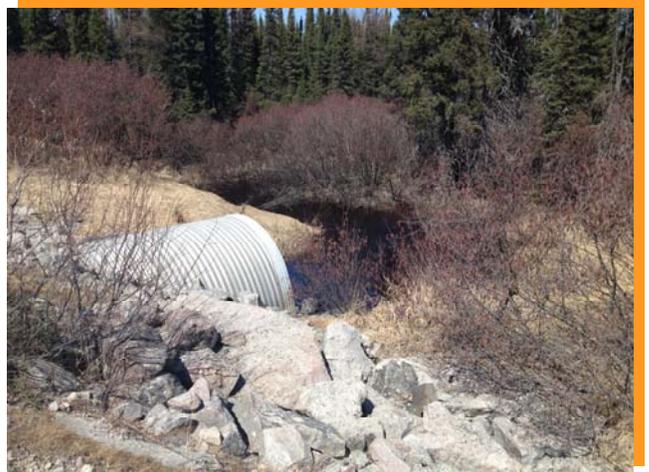
Photo 90: 12+450 – TTOG 3000 – Low flow

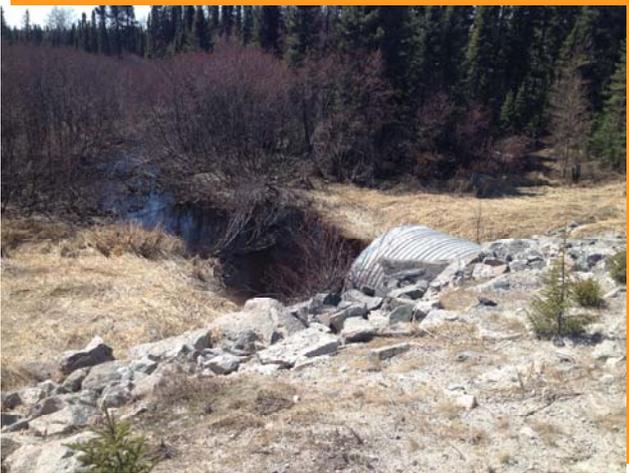
Photo 91: 12+450 – TTOG 3000 – Low flow

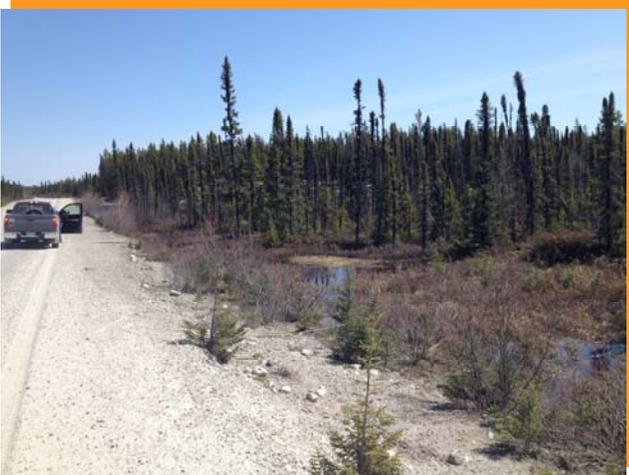
Photo 94: 14+050 à 14+250 – Accumulations of water trapped by terrain (roc)

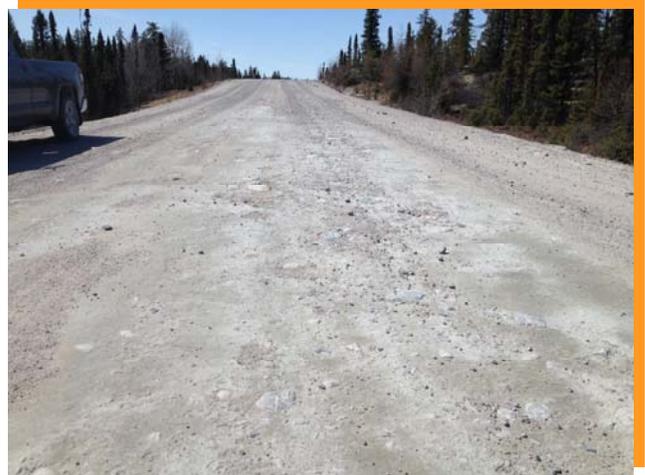
Photo 95: 14+700 – Sub-base material on surface

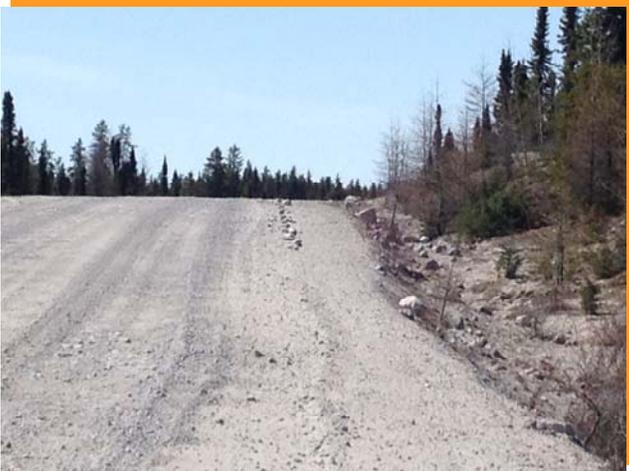
Photo 96: 14+700 – Sub-base material on surface

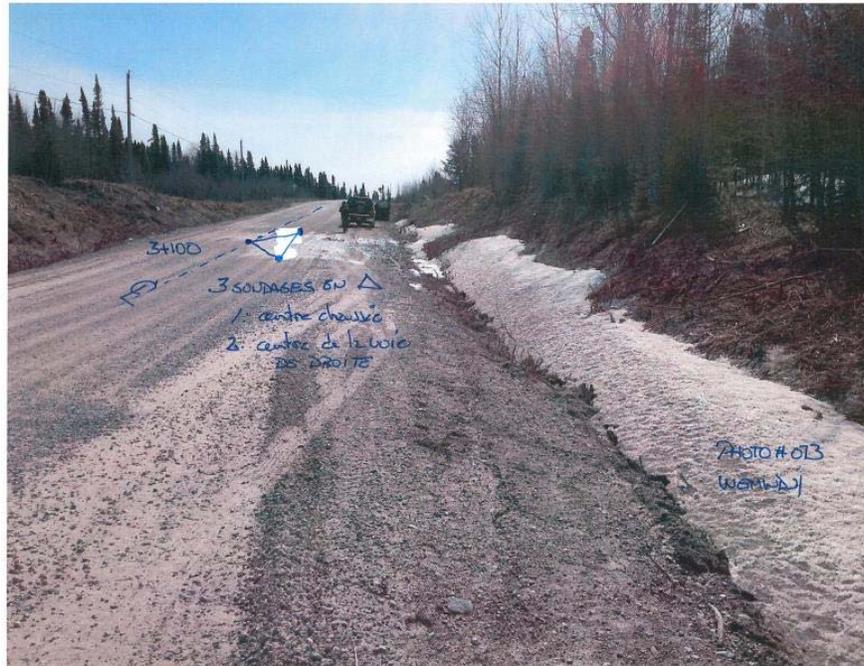
- ▶ TF-16-15, TF-17-15 et TF-18-15 au chainage 3+100 afin de vérifier la condition des matériaux au site d'une résurgence d'eau à la surface de la chaussée, dans une pente vers un pont. Le journal des sondages de l'annexe 2, ainsi que la photographie 1 de l'annexe 5, indiquent la position des sondages relativement au point de résurgence d'eau;

Photo #1 : Sondages_resurgence

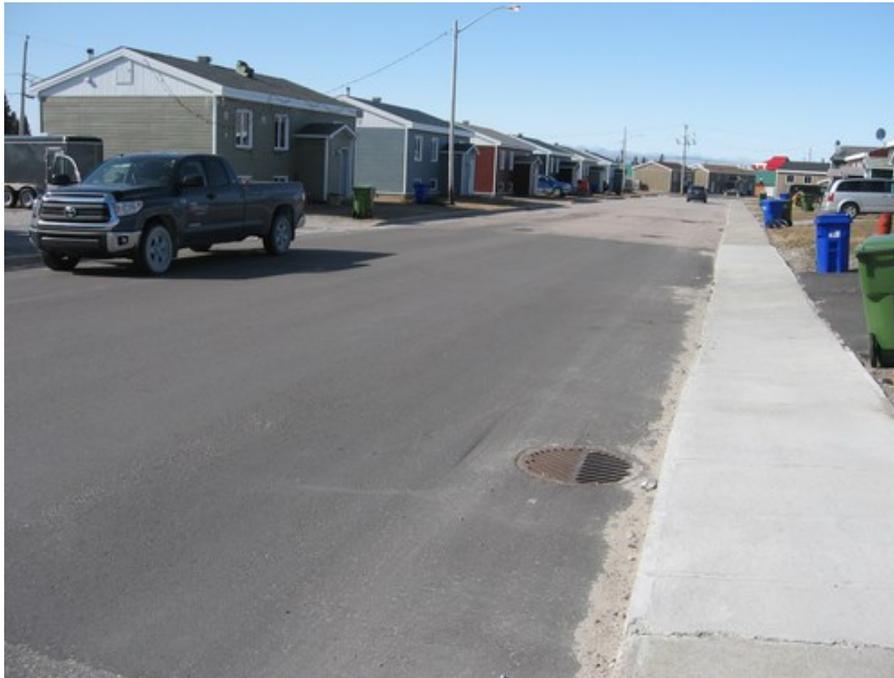
Le tronçon pavé à l'étude de la rue Beaver Road, localisée entre les rues Cluster 1 et Hillside, est affecté par des déformations et des fissures majeures, particulièrement durant l'hiver. Les photographies 2 et 3 de l'annexe 5 illustrent la situation. Une section de ce tronçon, localisée entre les rues Cluster 1 et Cluster 2 a fait l'objet d'une réparation dont la nature n'est pas actuellement connue, tel que montré à la photographie 4 de l'annexe 5.

Photo #4 : Section_réparée_Beaver_Road

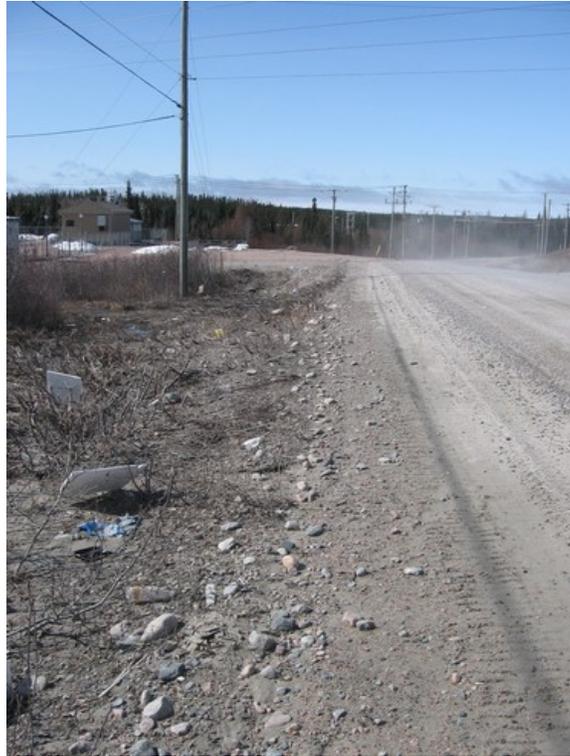
Photo #7 : Cailloux_en_rive
